The Thyssen Krupp Accident in Torino: Investigation Methods, Accident Dynamics and Lesson Learned

The Authors of this paper were technical consultants of the Public Prosecutor in the trial for the accident occurred at the ThyssenKrupp(TK) plant in Turin on Dec. 6, 2007.

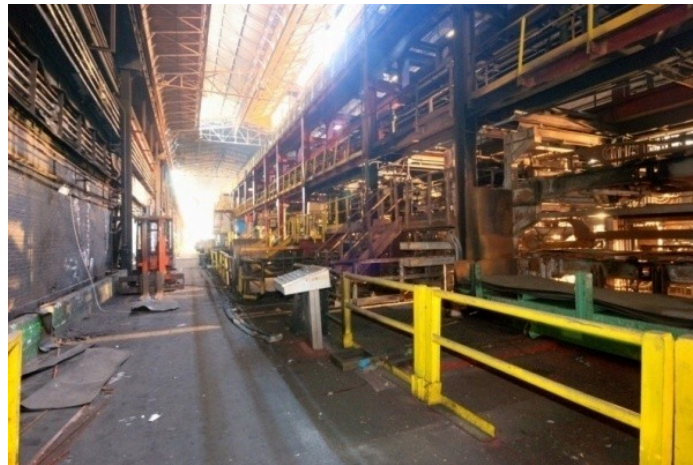
Figure 1: the area subject to the accident

An area roughly 20 m X 20 m X 6 m height presented evident heat damages (Figure 1) due to the presence of fire. The higher fire damages were evident in the area of the flattener (see Figure 1), where many hydraulic pipes collapsed. The coil under process presented damages due to striking against the iron carpentry on one border. Evident striking effects were detected up to some 290 m downstream the coil, till the bridge n. 3. Further 90 m of tape presented minor striking effects, which were present up to the chemical section entrance. Inside the chemical pool the coil presented evident corrosion occurred after the shutdown. As a consequence it was no longer possible to assess about coil scratching. The coil border up to the oven was coloured in blue-violet (Figure 4), indicating that the border reached a high temperature due to striking. A deep cut in the iron carpentry located roughly 60 cm above the flattener was recognised as the main striking location (see Figure 5).

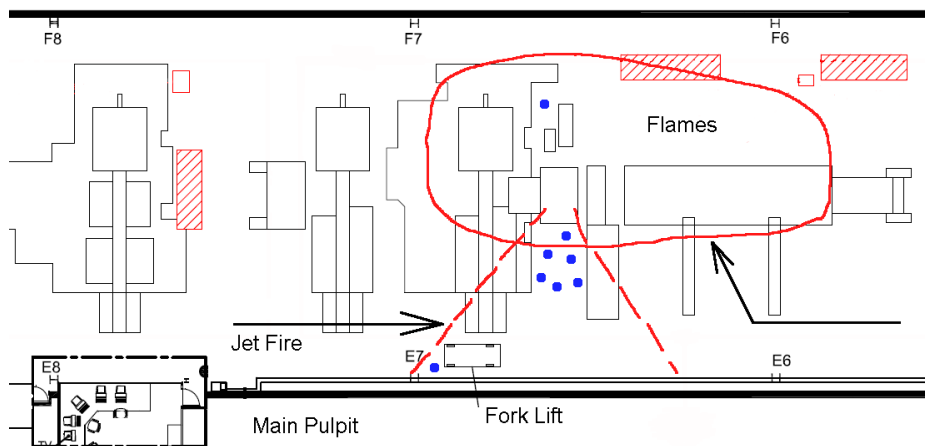
At that moment a hydraulic pipe (roughly 10 mm inner diameter) suddenly collapsed and released from the pipe fitting. The pipe was fed at the pressure of 70 bar by the main oil pump station, which was still running. As a consequence a spray of hydraulic oil was released into the existing fire. The ignition of the spray was immediate, resulting in a huge jet fire that hit almost directly all the eight workers. Figure 1 shows the site and Figure 2 shows a map of the site where the position of the workers and the extension of the area hit by the jet fire are indicated. The jet fire length was not determined precisely, since it hit the front wall that was located at a distance of more than 10 meters from the release point. The fire, due to the interaction of the fluid with the structures, spread also backwards with respect to the hose direction, in such a manner to include a significant wider area as indicated in Figure 2.

Figure 2: plot of the area interested by the flames, by the jet fire and position of the workers (blue dots).

The jet fire hit the eight workers that were fighting the first fire. Of them, the one that was close to the fire hydrant (see Figure 2), was shielded by a fork lift and could be able to suffer only minor burns. Six were hit from the jet fire and suffered 3rd degree burns ranging from the 60 % to the 90 % of their body. They died in the following month. One, which went to the back side of the plant to fight the fire, was trapped and died immediately. The fire spread to the machines and lasted for approximately two hours, before the fire brigade could extinguish it.

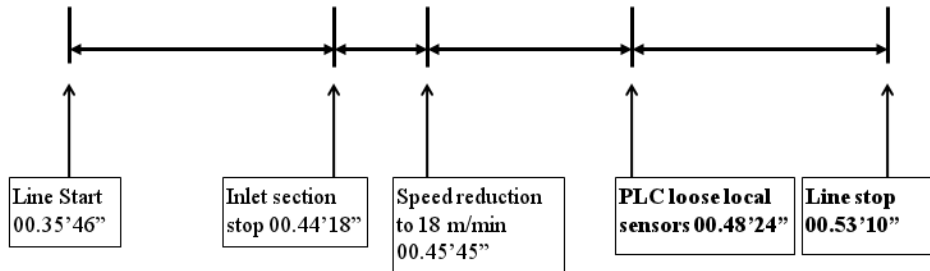
From the analysis of the control system recording the time scale of the events resulted as indicated in Figure 3. The first pipe collapsed in a time interval between 00:45'45" and 00:48'24", the pumps were stopped by the control system at 00:53'10" due to low level switch system based on the oil level in the main reservoir. In this time interval roughly escaped some 400 L of hydraulic oil.

Figure 3: Time scale of the events(from the analysis of the control system records)

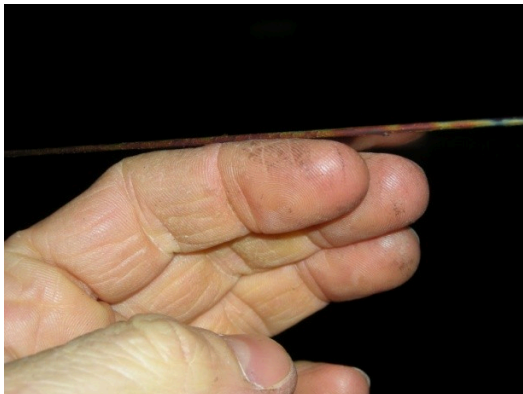
Figure 4: Consequences of coil striking

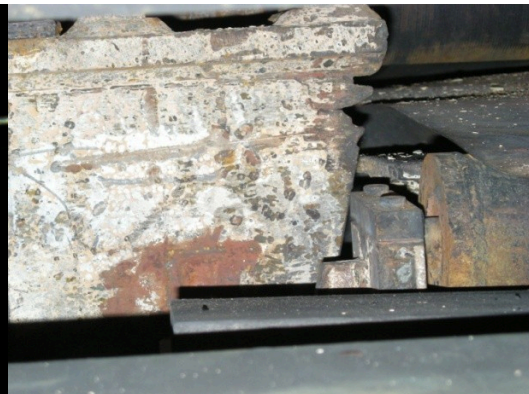
Figure 5: striking location
