Analysis of Partial Fractures on Aircraft Composites Wing

In the stability test of an aircraft composites wing, partial fractures are found in the rivet joint region of the wing skin panel. Besides visual examination, other experimental techniques used for investigation are: crack morphology and fracture characteristics by environmental scanning electron microscopy (ESEM), metallographic observation of cracks and composition analysis of fiber surface by x-ray fluorescence spectrometry (XFS). The results are obtained through the analyses of damage morphology, structure stress and load. Fracture areas of the panel, in which notch effect was formed around the rivet, fractured under alternate compressive load. The wing skin panel fractured at the rivets under compression load. For the inconsistent deformation in the compression process, the damage mode of local areas is shear fracture. The primary cause of the panel fracture is insufficient design strength. However, interface pollution leads to structural strength decline, which induces the fractures occurred.

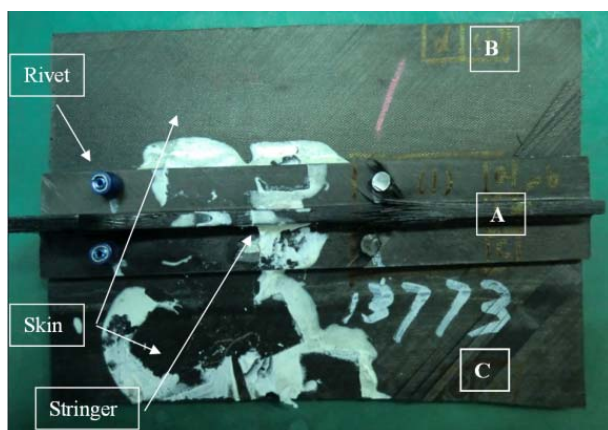
Figure 1: Partial fracture in the wing skin panel a

Some specimens were cut from the damage area for metallographic observation, as is shown in Figure 1 (Region A, B and C). In region A, skin plies delaminate, and there are also some longitudinal cracks. However, few delaminations and cracks can be found in the stringer bottom near co-curing interface (see

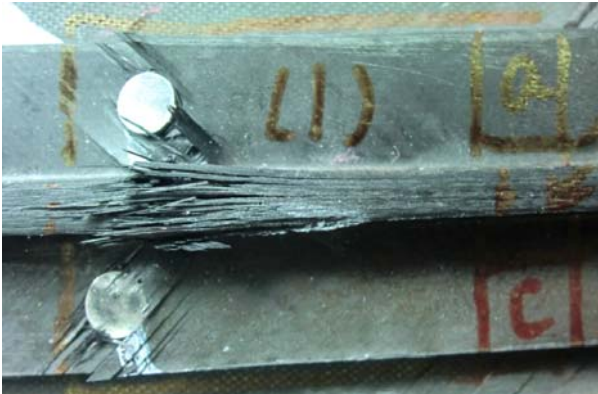
Figure 2: Partial fracture in the wing skin panel b

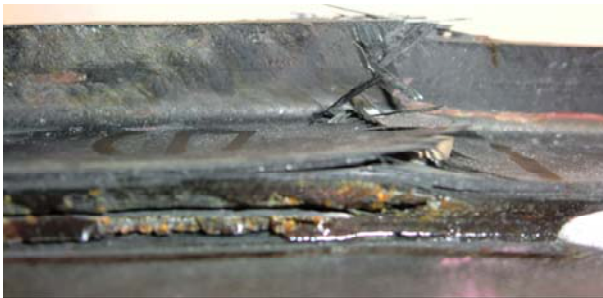
Figure 3: Surface morphology of fracture

It can be seen clearly that there are some cracking traces on the skin bottom surface, as is shown in Figure 3. In the both ends of the fracture, stringer dislocates with an angle on the fracture both sides, and there are interlaminar cracks in stringer near the interface of stringer and skin. In the front-end, cracks propagate from the right to the left, but it is just contrary to that of the rear-end. In the area, the stringer bottom arched after buckling around the fracture (see Figure 4). Skin seriously delaminates, and the plies of skin completely crack along the interlamination, but there are some longitudinal cracks across

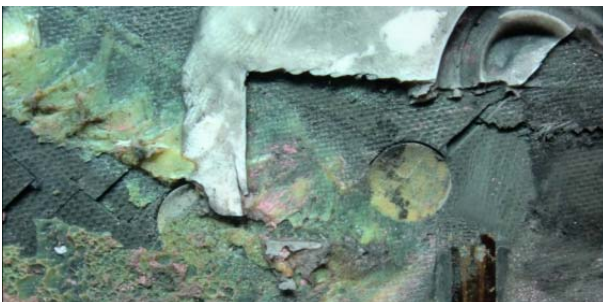
Figure 4: Stringer fracture morphology

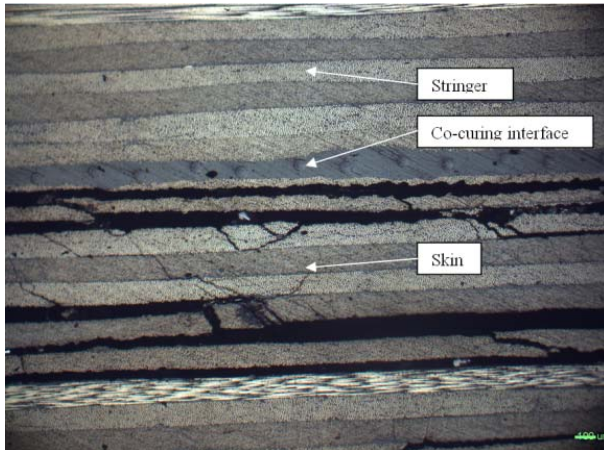
Figure 5). Damage morphologies of skin by the both ends of stringer are slightly different. There are some longitudinal cracks in the front-end of stringer, which connect with the interlaminar cracks. The nearest co-curing interface ply has cracked, and the cross crack is characterized by ragged fracture. The longitudinal cracks penetrate one or two plies and connect with the interlaminar cracks. The cracks opening points to the co-curing interface (see Figure 6). There are interlaminar cracks in the skin plies nearby the stringer in region B and region C. However, in region B the fractures fragmentize and more longitudinal cracks exist.

Figure 5: Region A metallographic morphology

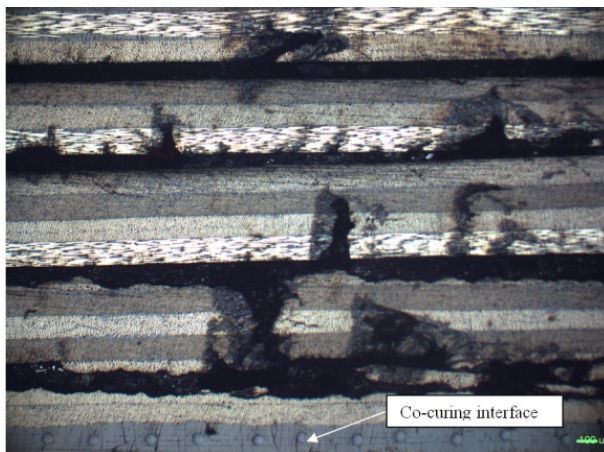
Figure 6: Longitudinal crack opening direction

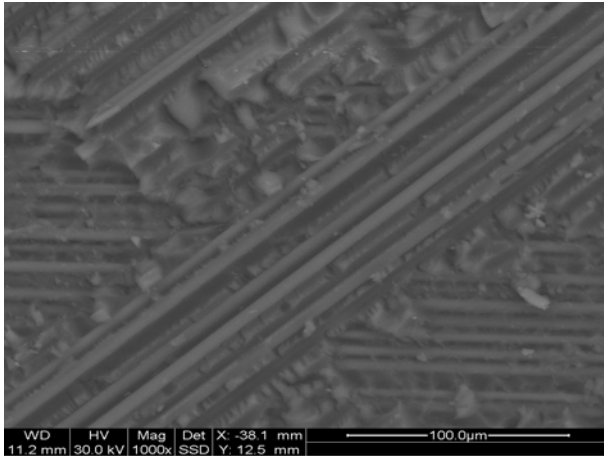
Specimens separately cut from region A, region B and region C were observed under ESEM. Each fracture is formed by interlaminar cracks, and the fractures are flat. There are some traces of matrix cracking and fiber pull-out break on the fracture, and longitudinal cracks which perpendicular to fiber direction can be found in local areas. On the fracture, fibers are bared smooth and matrix remains smooth indentation. Several fibers broke with a positive fracture. Uneven fractures and fibers irregular breakage can be found in the skin nearby co-curing interface (See Figure 7, Figure 8, Figure 9).

Figure 7: Fracture morphologies by ESEM a

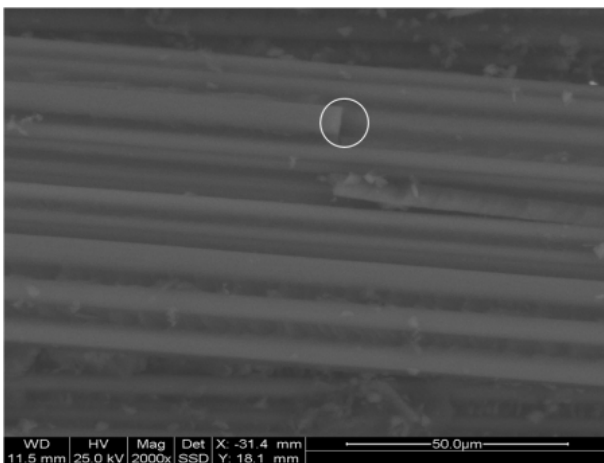
Figure 8: Fracture morphologies by ESEM b

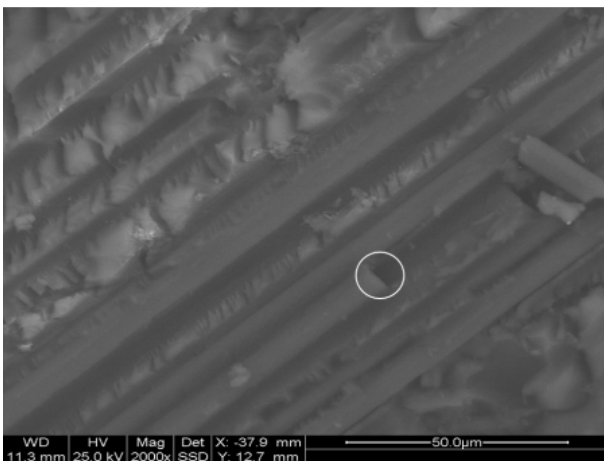
Figure 9: Fracture morphologies by ESEM c
