## Analysis of Partial Fractures on Aircraft Composites Wing

In the stability test of an aircraft composites wing, partial fractures are found in the rivet joint region of the wing skin panel. Besides visual examination, other experimental techniques used for investigation are: crack morphology and fracture characteristics by environmental scanning electron microscopy (ESEM), metallographic observation of cracks and composition analysis of fiber surface by x-ray fluorescence spectrometry (XFS). The results are obtained through the analyses of damage morphology, structure stress and load. Fracture areas of the panel, in which notch effect was formed around the rivet, fractured under alternate compressive load. The wing skin panel fractured at the rivets under compression load. For the inconsistent deformation in the compression process, the damage mode of local areas is shear fracture. The primary cause of the panel fracture is insufficient design strength. However, interface pollution leads to structural strength decline, which induces the fractures occurred.

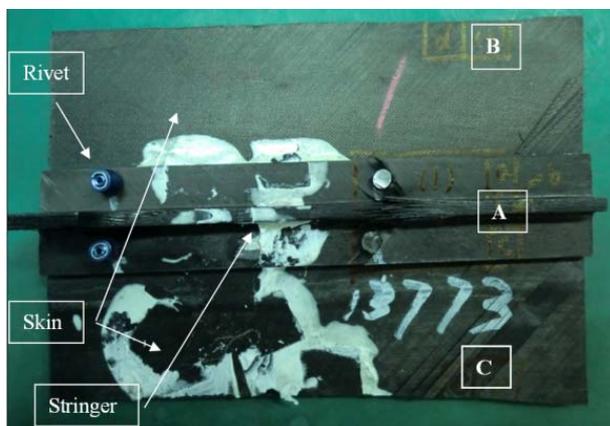
Figure 1: Partial fracture in the wing skin panel a

Some specimens were cut from the damage area for metallographic observation, as is shown in Figure 1 (Region A, B and C). In region A, skin plies delaminate, and there are also some longitudinal cracks. However, few delaminations and cracks can be found in the stringer bottom near co-curing interface (see

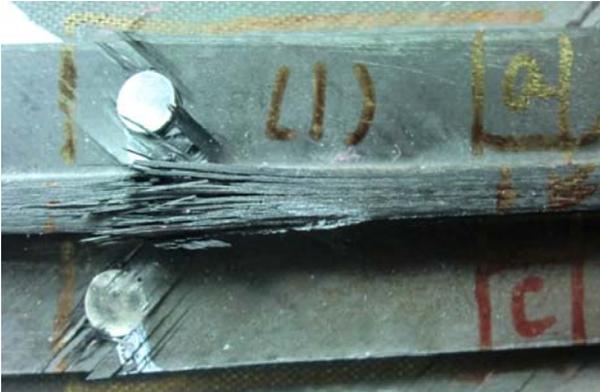
Figure 2: Partial fracture in the wing skin panel b

Damage panel has fractured at the right rivets, which stringer fibers are broken completely, the main crack penetrates the panel.

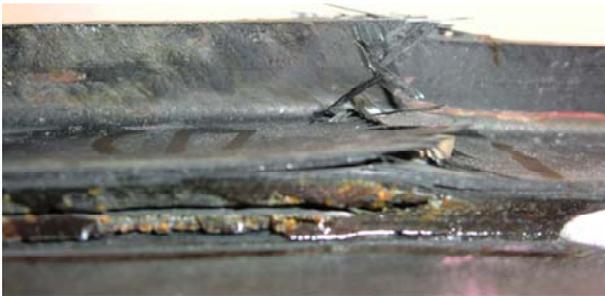
Figure 3: Surface morphology of fracture

It can be seen clearly that there are some cracking traces on the skin bottom surface, as is shown in Figure 3. In the both ends of the fracture, stringer dislocates with an angle on the fracture both sides, and there are interlaminar cracks in stringer near the interface of stringer and skin. In the front-end, cracks propagate from the right to the left, but it is just contrary to that of the rear-end. In the area, the stringer bottom arched after buckling around the fracture (see Figure 4). Skin seriously delaminates, and the plies of skin completely crack along the interlamination, but there are some longitudinal cracks across

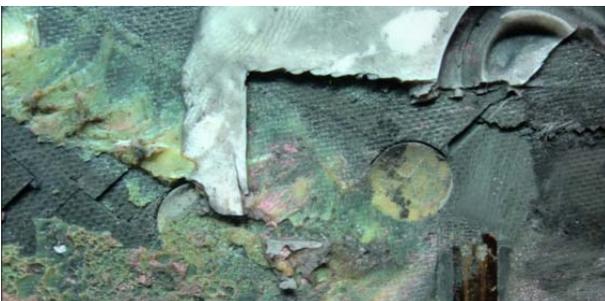
Figure 4: Stringer fracture morphology

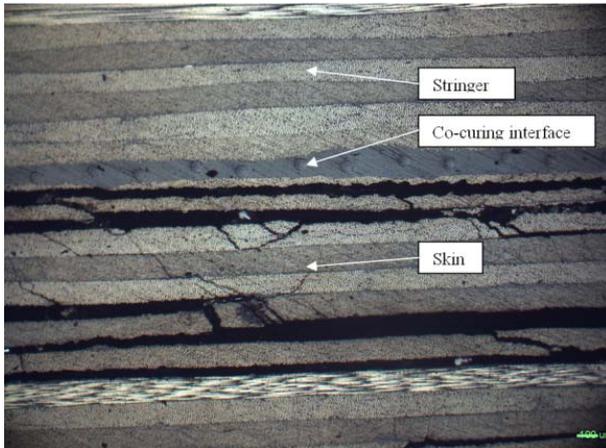
Figure 5). Damage morphologies of skin by the both ends of stringer are slightly different. There are some longitudinal cracks in the front-end of stringer, which connect with the interlaminar cracks. The nearest co-curing interface ply has cracked, and the cross crack is characterized by ragged fracture. The longitudinal cracks penetrate one or two plies and connect with the interlaminar cracks. The cracks opening points to the co-curing interface (see Figure 6). There are interlaminar cracks in the skin plies nearby the stringer in region B and region C. However, in region B the fractures fragmentize and more longitudinal cracks exist.

Figure 5: Region A metallographic morphology

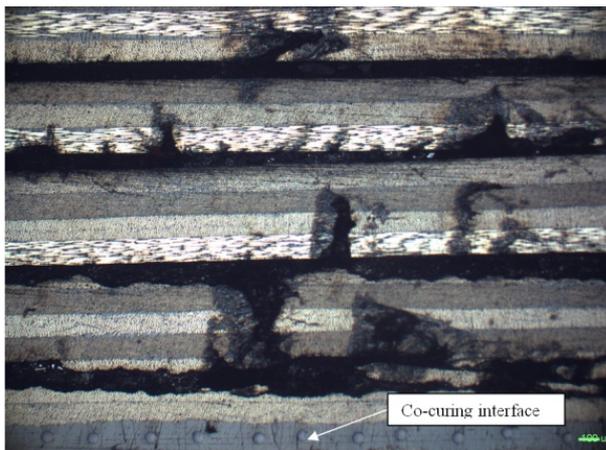
Figure 6: Longitudinal crack opening direction

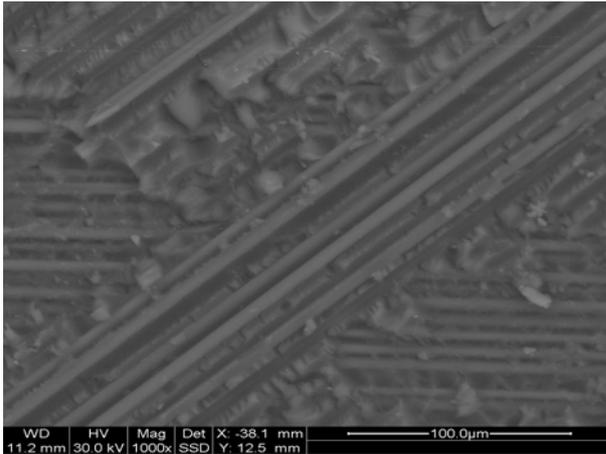
Specimens separately cut from region A, region B and region C were observed under ESEM. Each fracture is formed by interlaminar cracks, and the fractures are flat. There are some traces of matrix cracking and fiber pull-out break on the fracture, and longitudinal cracks which perpendicular to fiber direction can be found in local areas. On the fracture, fibers are bared smooth and matrix remains smooth indentation. Several fibers broke with a positive fracture. Uneven fractures and fibers irregular breakage can be found in the skin nearby co-curing interface (See Figure 7, Figure 8, Figure 9).

Figure 7: Fracture morphologies by ESEM a

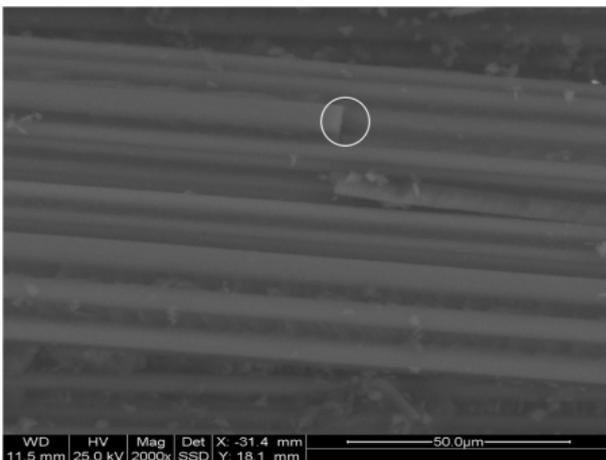
Figure 8: Fracture morphologies by ESEM b

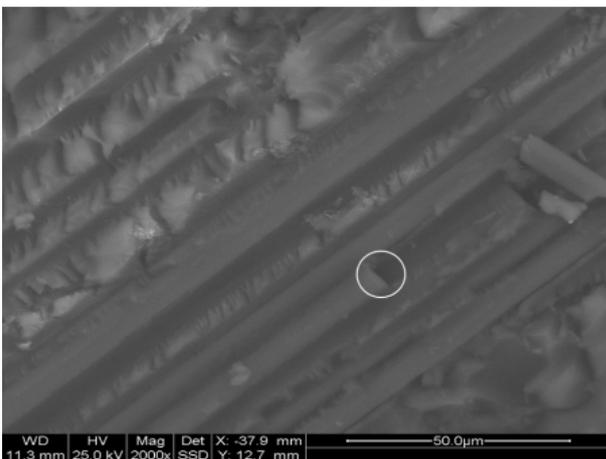
Figure 9: Fracture morphologies by ESEM c
