## New Insights into the Viareggio Railway Accident

Davide Manca

The Viareggio railway accident took place in the night of June 29<sup>th</sup>, 2009, with the derailment of a freight train, the emission and dispersion of more than 45 t of LPG, the ignition and explosion of the dense gas cloud, and the liquid pool fire. Eventually, the accident consequences were relevant with 32 fatalities, 26 casualties, and property losses valued at tens of millions of euros. Some papers report the most important facts and the simulations that were done in the months just after the accident to understand at different levels what happened and to depict the most probable accident dynamics. Most of the input data to the simulation models, reported in the scientific literature, were based on reasonable assumptions and hypotheses often deduced by public domain material such as articles on newspapers and videos on the Internet. The main problem about the reliability of the simulations was that the accident scene was put under judicial attachment by the public prosecution's office. The measured data and the analyses performed by the investigatory commission were not available publicly. Consequently, t

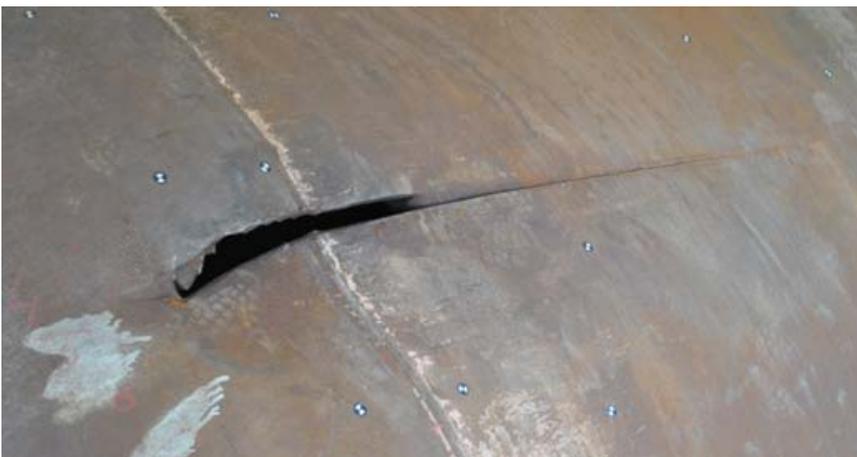
Figure 1: Detail of the cut produced in the metal casing of the first tank car.

There is a large debate on the object that produced the deep cut in the metal envelope of the first tank car. There is a unanimous agreement on the impact of the overturned tank car being produced by a metal object. Figure 1 suggests that no other material but steel could cut the envelope of the car so easily. The clear and deep cut in the thick metal sheet of the tank car also suggests that the object had to be acuminated and stiff enough to stand to the direct and prolonged impact so to keep on producing the 50 cm long cut. A first hypothesis about the metal object is based on a railway stake. Stakes obtained by railroad segments are frequently thrust in the ground for reference, measurement, and maintenance purposes. Usually these stakes are 1.5 m long and emerge from the ground by one third of their length. The stake was bent by the collision with the derailed train and its tip exhibits a glossy and blunted surface whose dimension is compatible with the cut width produced in the first car.

It is worth reporting that tank cars are designed to stand to derailment and overturning. Only the first tank car underwent the cut in the envelope because it hit a sharpened and stiff metal object. On the contrary, the other four overturned cars scraped against the railroads and the ballast but resisted mechanically and did not release the LPG freight.

- Discharge coefficient. This parameter affects the modeling of liquid outflows in case of irregularly damaged sheet steel with jagged edges (see also Figure 1). Manca and Brambilla, 2010, assumed a discharge coefficient equal to 0.62, in line with the literature recommendations for releases from

sharp edged holes (van der Bosch and Duijm, 2005; McIntyre and Ford, 2009). However, the rectangular shape of the hole and the thick burr bent inside would deserve a dedicated discharge coefficient (to be ideally determined through experiments).

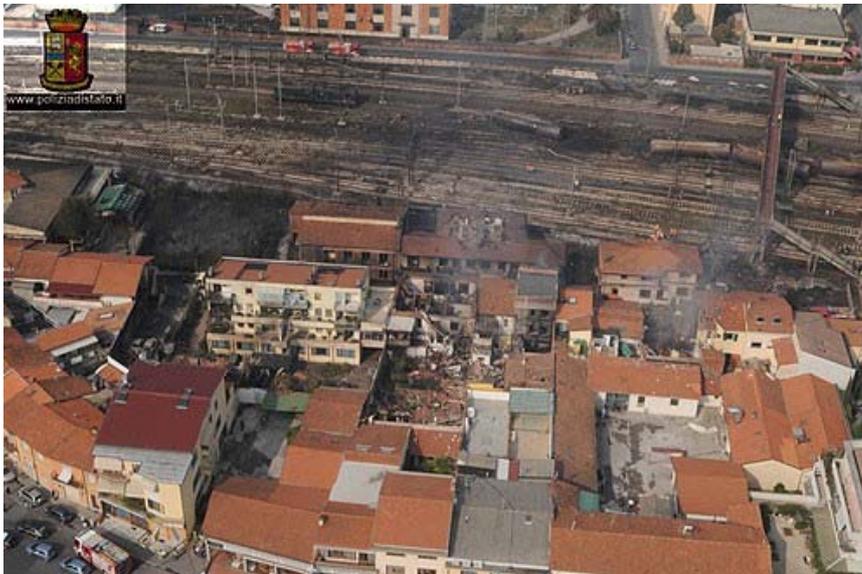
Figure 2: Random effect of gas penetration in the buildings exposed to the dense gas dispersion.

Figure 2 shows the consequences of internal explosions inside the houses that were involved by the dense gas penetration and ignition. The explosions were clearly internal; otherwise, a supposed external explosion would have equally damaged the adjacent houses, which is not the case. On the top diagonal part of Figure 2, one can observe Ponchielli Street that was set on fire. Most buildings and parked cars were completely burnt away. The flash fire of the external cloud and the hot gases and debris released by the internal explosions produced a domino effect on the surrounding properties.
