Kaohsiung Vapour Explosion - A Detailed Analysis of the Tragedy in the Harbour City

Hui-Ning Yang^{a,b}, Jen-How Chen^a, Home-Jo Chiu^a, Ting-Jia Kao^{a,b}, Hsiao-Yun Tsai^{a,b}, and Jenq-Renn Chen^{a,b*}

On the midnight of July 31st, 2014, a catastrophic vapor explosion occurred in the downtown of Kaohsiung city. The incident was initiated from a leak of an underground pipeline transporting pressurized propylene liquid. Analysis of pipeline operation logs and pipeline break release modeling suggested that at least 90,000 kg of propylene leaked, entered the underground trench and spread into the trench 4.5 km in distance before meeting an ignition source some three hours later after the leak. The ignition caused a significant vapor explosion which blew out the road above the underground trench, damaged more than one hundred vehicles on the road with thirty two fatalities and more than three hundred injuries. This article takes an in-depth look at the explosion incident covering the events leading to the explosion, explosion damage, cause of the leak, spread of the leak, and identification of a probable ignition source. Lessons learnt and recommendations are given to prevent and m

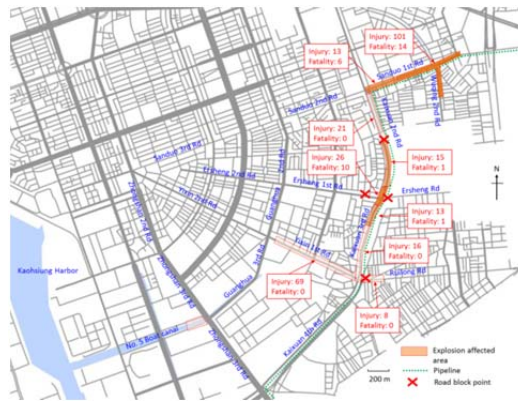
Without any warning, an explosion occurred near the command post on 23:57 July 31st. The explosion was occurring beneath the road surface with a smoke erupting out from the storm water trench manhole, followed by road surface crack, and a large fire erupted out. The road surface was blown out and pushed upwards all vehicles and personnel on the road and then collapsed to the trench. Figure 1 shows the explosion affected area, the distribution of casualties and the pipeline route. The explosion propagated along the Kaixuan 2nd road to the north and Kaixuan 3rd road to the south along the storm water trench. At the end of Kaixuan 2nd road, the explosion propagated towards Sanduo 1st road and its junction to Wuqing 2nd road. A total of 4.5 km road were blown out.

Figure 1: The explosion affected area, the distribution of casualties and the pipeline route.

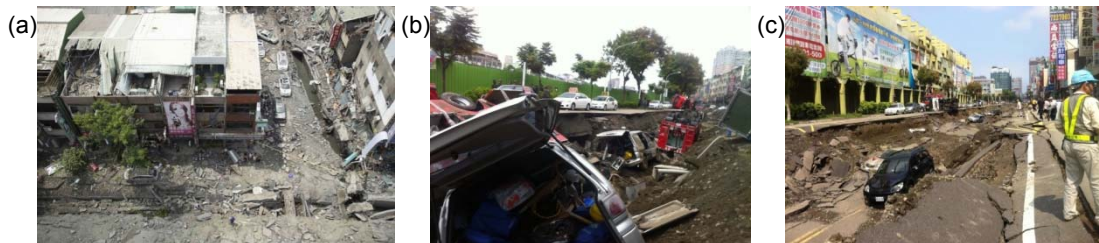
Figure 2 shows photos of explosion damage at different roads. The junction of Sanduo 1st road and Wuqing 2nd road suffered the largest fatalities and injuries as indicated in Figure 2(a). Wuqing 2nd road is famous for many midnight snack shops. A total of fourteen civilian were killed by the blast wave and fire ball while more than one hundreds were injured. Another factor contributed to the significant fatalities in this area is that the road surface covering the storm water trench was only about 0.5 m which is very thin comparing with the 1 ~ 2 m in other roads. The explosion not only blew out the road surface but also shattered the road into small fragment and debris. Casualties were most caused by the debris impact and the explosion flame.

The second largest fatalities were occurred in the junction of Kaixuan 2nd road, Kaixuan 3rd road, and Ersheng 1st Road which centred around the incident command post. Fire trucks that parked on the Kaixuan 2nd and 3rd roads and were overturned by blown out road as shown in Figure 2(b). More than twenty fire fighting trucks were damaged along with three emergency response vehicles from EPA Specialist Team. Seven of the ten fatalities on this road junction were fire fighters. The explosion damage on the south side of Kaixuan 3rd road and Yixin 1st Road was less severe compared with other area as shown in Figure 2(c). It is likely that most explosion energy was dissipated by the thick road surface on top of the storm water trench. The explosion on the Yixin 1st road continued through the storm water trench near Guanghua 3rd road eventually vented through the No. 5 boat canal and blown out the canal terminal.

Figure 2: Photos showing the explosion damage near (a) the junction of Sanduo 1st road and Wuqing 2nd (b) the south side of Kaixuan 3rd road and (c) Yixin 1st.

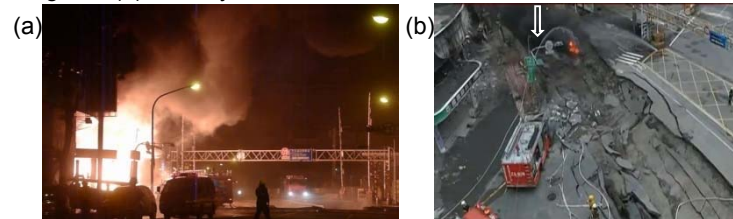
After the explosion, a large jet fire developed near the junction of Ersheng 1st Road and Kaixuan 3rd Road as shown in Figure 3(a). This was the largest fire after the explosion and it lasted till 6 am the following day. As the fire diminished gradually, it can be seen clearly that the fire was coming out from a branch of storm water trench as indicated in Figure 3(b). Clearly, this would be the source of leak.

Figure 3: Photos of the fire after the explosion on the north side of junction of Kaixuan 3rd road and Ersheng 1st road. Time of the photos: (a) 12:00 am (b) 06:00 am.

As the area were blocked for traffic, the only available ignition sources were the fire trucks which remained running to provide firewater. In fact, there was a fire truck near the junction of Ersheng 1st road and Kaixuan Road as shown in Figure 3(b). Further investigation revealed that the fire truck was sit on top of an electrical cable junction box cover. The electrical cable junction box is not sealed but usually drained to nearby storm water trench. It is very likely that the vapour in the storm water trench spread out into the junction box, and eventually escaped the cover to meet the truck engine and ignited. The analysis suggests the importance of strict control of ignition source during a flammable release. In fact, the only safe outcome of such a large release of flammable vapour into a confined space is a slow dilution to below flammability limit. Either premature ignition or recovery of flammable vapour is extremely difficult and risky to do.

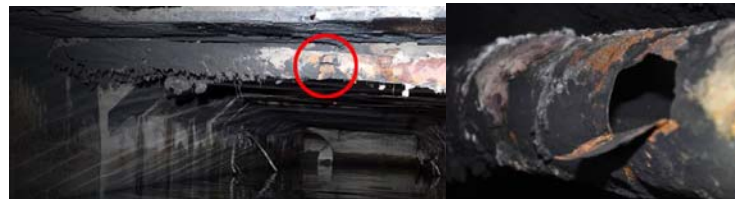
Subsequent inspection of the trench branch with jet fire revealed that there were three pipelines passing through the trench. The 4-in line was completely exposed in air and had a break opening of 4 cm by 7 cm as shown in Figure 4. The 6-in and 8-in lines were located next to the 4-in line, partially exposed in air, and remained intact. Inspection of the leaked pipeline also showed pipeline wall thickness greatly reduced from its original 6 mm to less than 1 mm by corrosion from the humid ambient environment in the trench.

Figure 4: Photos of the storm water trench, the 4-in propylene pipeline and the break.

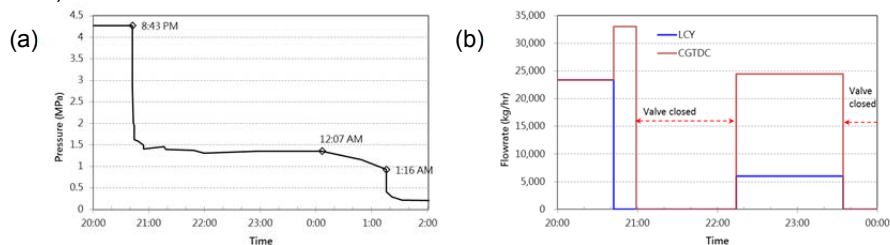
It is important to estimate the leak rate and amount of leaked in order to assess the potential damage and evacuation zone. The leak rate was dominated by leak opening and the pipeline pressure. Figure 5(a) shows the pipeline pressure recorded at Taiwan CPC Cianjhen terminal which is a branch line to the CGTDC and LCY pipeline. As the Taiwan CPC Cianjhen terminal was close to CGTDC pumping station, the recorded pressure can be a good approximation of the upstream pressure of the leak. As the boiling point of propylene is far below the ambient pressure, the leak from the pipeline may or may not flash depending on the upstream pressure. If the upstream pressure is higher than the saturation vapor pressure, the propylene may leak out as a liquid before flashing (Crowl and Louvar, 2012). If however the upstream pressure is close to the saturation pressure, flashing is expected and the typical two-phase flashing flow across an orifice may be used (Crowl and Louvar, 2012).

Figure 5: (a) Pipeline pressure recorded at Taiwan CPC Cianjhen terminal, a branch line to the CGTDC and LCY pipeline. (b) Recorded flowrate on CGTDC and LCY side

As Figure 5(a) indicates that the pipeline upstream pressure after the break was very close to propylene saturation pressure, flashing two-phase flow will be the dominant mode of leak. Although more detailed

Figure 5(b) showed the recorded flowrate on CGTDC and LCY side. The area difference between the two records will be the amount lost during pumping and mostly in liquid form. Direct integration gives 34,000 kg. For the valve closed period, a total of 97 min, the loss is calculated to be 56,800 kg from the vapour choked flow equation and 160,000 kg from the flashing flow equation. The latter is far larger than the possible pipeline inventory of 100,000 kg based on the 27 km of pipeline volume and propylene density. As expected, the value from vapour choked flow calculation is considered a more realistic value compared with that from flashing flow equation. Thus, a total of 90,000 kg propylene was estimated to leak before the ignition.

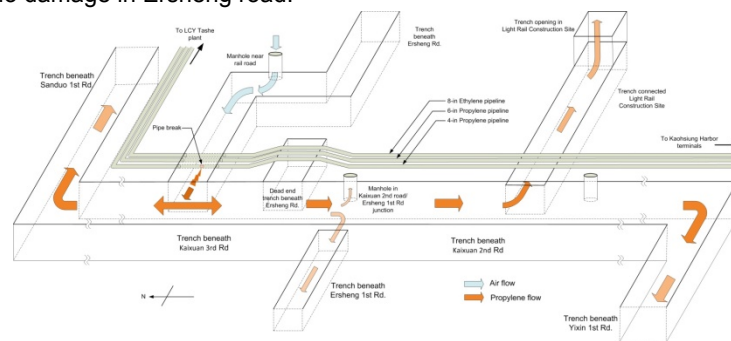
Although the source of the leak was confirmed, it is important to know how the leak in the trench was spread to cause such a large damage. Subsequent investigation revealed that there were two storm water trench branches, one being directly beneath the Ersheng Road but is only 7 m in length and sealed in the other end, the other being about 10 m north of the dead ended branch and housed the pipelines. The later was then connected to the trench beneath Ersheng Road. Figure 6 put up a schematic diagram showing all the trenches and trench openings. The trench branch that housed the pipeline had a manhole upstream which was the manhole with the suction sound. As the pipe break was facing towards the main trench, the break leak would form a jet and entrained significant air from upstream and thus the manhole. Thus, the direction of the leak is in consistent with the finding of suction sound in the upstream manhole. It is also consistent with the fact that there was virtually no damage in Ersheng road.

Figure 6: Schematic diagram of storm water trench, the pipeline, and the spread of the leak propylene.

In addition, the leak jet entered the main trench and spread both sides to Kaixuan 2nd and 3rd roads. This is in agreement with the fact that the manhole on the junction of Kaixuan 2nd road and Ersheng 1st road was the initial spot of vapour spread out of the trench to ground. Furthermore, a branch on the Kaixuan 2nd road was connected to the light rail construction site with a very large opening of 3 m by 3 m. This opening provided the least resistance for propylene vapour to escape to the ground and was considered the major source of leak before the explosion. Interestingly, the opening also provided a vent during explosion which reduced the explosion overpressure in that branch and therefore the ground above the branch was intact.
