# Investigation and Analysis of an Explosion at the GOEX Black Powder Manufacturing Facility

Ali Reza<sup>\*a</sup>, Zuhair Ibrahim<sup>a</sup>, Tim Vaitekunas<sup>b</sup>

<sup>a</sup>Exponent, Inc., 5401 McConnell Ave, Los Angeles, CA, USA

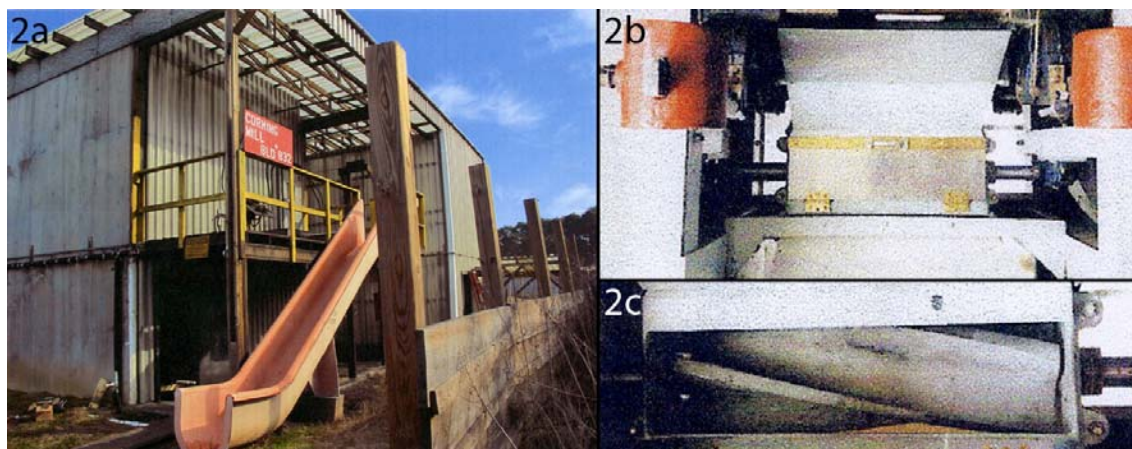
Figure 2: Corning mill (a), hopper (b) and aluminium worm (c)

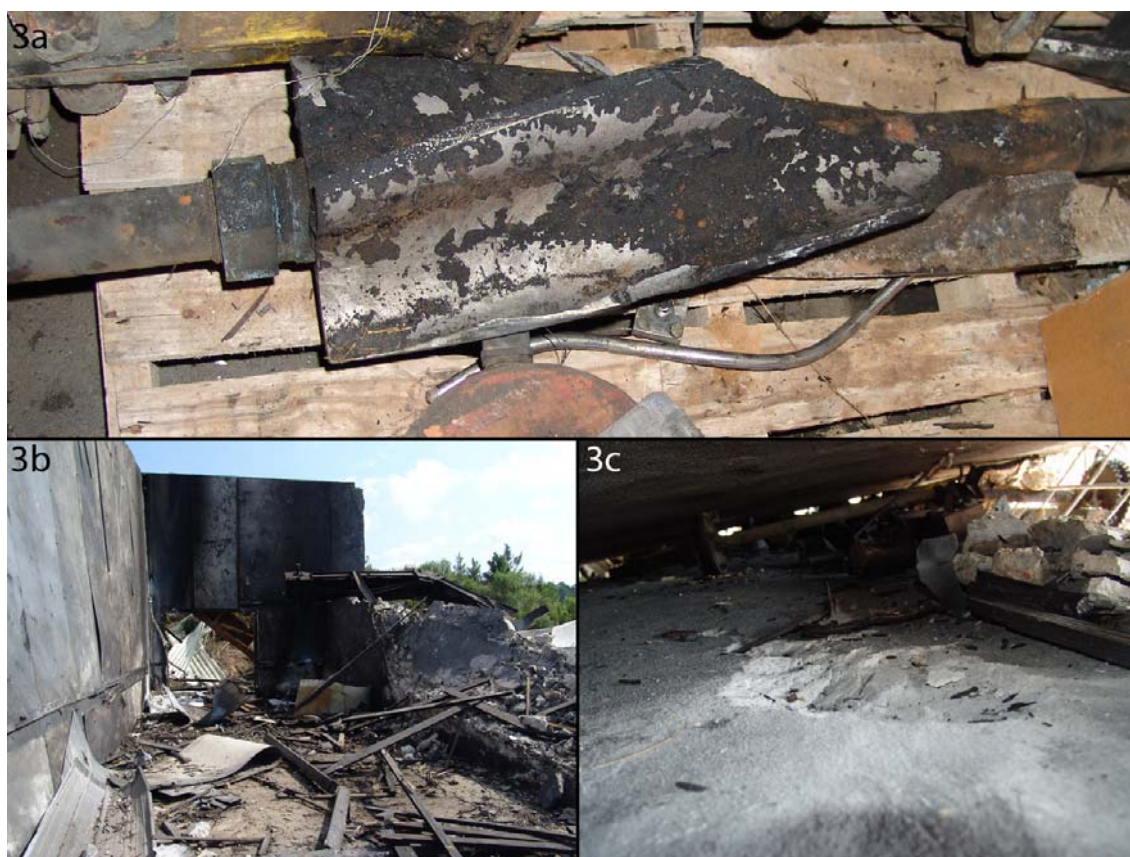
Figure 3: Fragmented worm (a), destroyed corning mill (b) and crater under hopper and worm (c)

Damage indicators documented by Exponent included the condition of the concrete floor slab and walls and recovered fragments of the cast aluminium hopper and the screw worm. Investigation confirmed that the origin of the primary explosion was inside the hopper directly above the worm at the head of the corning mill screens and rollers. The primary explosion fragmented the hopper and the aluminium worm

Careful examination of the floor confirmed that the only evidence of localized cratering in the concrete occurred directly under the hopper, which confirmed that the primary explosion occurred within this equipment (Figure 3c). The lower portions of the surrounding concrete walls were also fragmented and had collapsed outward onto the floor slab immediately around the hopper. Multiple fragments of the aluminium hopper and worm recovered after the explosion ranged in size from 1 inch to 9 inches, indicating a relatively high degree of brisance, particularly within the hopper (Figure 4a). Many fragments also exhibited surface cracks characteristic of high strain rates (Cook, 1958) that would be expected at the seat of the explosion (Figure 4b). Basco et al. (2010) indicate that the heat of explosion of black powder is approximately 60 % of TNT. Since the mill had operated for approximately 10 min prior to the explosion, the quantity of black powder within the hopper at the time of the explosion was approximately 158 kg (400 lb.), or a TNT equivalent quantity of 95 kg. Assuming a 1 m standoff distance between the hopper and the concrete slab, a detonation within this quantity of explosives is sufficient to cause the localized cratering observed.

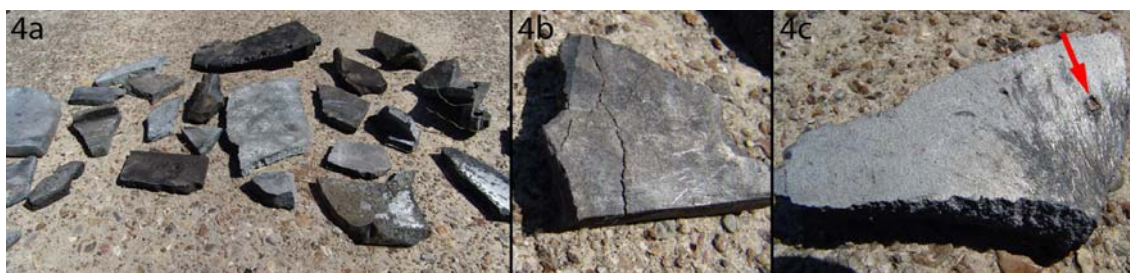
Figure 4. Recovered hopper fragments (a), cracks on hopper fragment (b) and embedded quartz (c)

A piece of quartz that had contaminated the chipped black powder from the press bay batch impacted the sides of the hopper. The friction generated sufficient heat to initiate the explosion. One of the recovered fragments from the hopper exhibited a distinct starburst pattern that is very characteristic of a surface initiation of explosives. A quartz pebble was also discovered embedded within this fragment, directly below the starburst pattern. Surface melting was observed on the aluminium surrounding and below the pebble (Figure 4c). Goex confirmed that, due to the design of the mill, a significant amount of material from each batch would spill on the ground during the corning operation. Operators would sweep the floor and incorporate this material into the subsequent batch as it was introduced into the hopper. Accordingly, accidental introduction of rocks or quartz into the mill (for example, materials being tracked into the mill by an employee) was quite possible.

An alternate mechanism for the explosion that could not be ruled out was a pre-existing defect or void in the cast aluminium worm that caused premature fracture within one of the worm blades as it turned. It is possible that a fragment of aluminium broke off and rubbed against the black powder, creating sufficient frictional heat to ignite the material. The subsequent ignition then propagated back into the hopper. Goex confirmed that they had last replaced the worm and hopper in 2006, and their procedures did not include any non-destructive testing or evaluation of rotating components to verify that there were no pre-existing defects or fractures in their equipment. However, Exponent was not able to recover any fragments that

exhibited localized melting on their fracture faces that would confirm this accident mechanism. We note that, despite extensive searches in the surrounding forest and swamp by Goex personnel, less than half of the hopper fragments could be recovered.

The plant had recently re-qualified a very detailed Process Safety Management plan, which included a hazards review as required by industry standards. Goex also maintained a strict series of Standard Operating Procedures designed to regulate step-by-step activities during the manufacturing process. However, the results of this investigation have highlighted certain structural shortcomings in their procedures that have since been corrected. Due to the obvious risk of foreign contaminants, floor sweepings should not be incorporated back into the manufacturing process. In addition, any equipment that rotates or otherwise imparts mechanical energy to explosives should be x-rayed or otherwise tested in a non-destructive manner to confirm that there are no occlusions, voids or other latent defects before it is placed into service. A regular non-destructive examination and requalification of the equipment should also be incorporated as part of the preventive maintenance program. The Process Safety Management plan and Hazards Review should include a What-if analysis to explore the effects of equipment failure in operations where energy is imparted to explosive materials.

The authors also reiterate certain NFPA 495 requirements that, in their experience, have not been consistently followed by industry and have caused explosions at other facilities. All explosives manufacturing and process areas should be regularly swept and kept clean, dry and free of grit, paper, empty packages and other assorted rubbish. Non-sparking tools should be used during all aspects of the manufacturing process, including housekeeping, and any floor sweepings should be disposed of in a manner approved for the explosive product itself. All collection systems should be cleaned at a frequency that eliminates hazardous concentration of explosives dusts or powder from accumulating in pipes, tubing and ducts or within hidden compartments. Finally, any explosive materials or residue should be removed from process equipment and the immediate surroundings before hot work or repairs that might produce heat sparks or flame is performed in the area.
