# Investigation of Odour Fade, and Subsequent Natural Gas Explosion at the San Diego Bayfront Hilton Hotel

Ali Reza, Zuhair M. Ibrahim\*

Exponent, Failure Analysis Associates, 5401 McConnell Ave, Los Angeles, CA, 90066 U.S.A.  
[zibrahim@exponent.com](mailto:zibrahim@exponent.com)

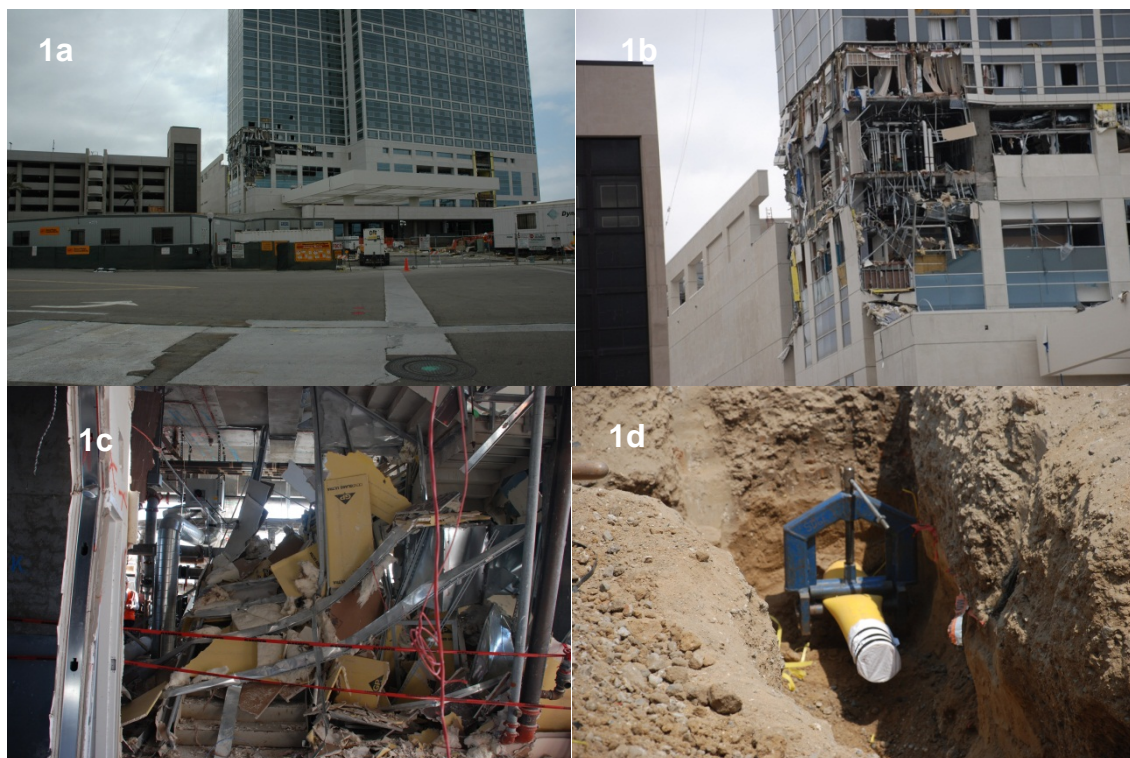
On May 19, 2008 at 14:15, a gas explosion originated on the fifth floor of the San Diego Hilton Bayfront hotel. The hotel was still under construction, and contractors were in the process of connecting and commissioning hot water boilers servicing the kitchen, laundry, and other hot water requirements. The explosion was centred in the fifth floor mechanical room, used to house six water boilers, several pumps, and a large hot water tank. Fifteen contractors were injured, and there was extensive damage to the equipment and the framing and windows for the fourth, fifth, and sixth floors (Figure 1a, 1b, and 1c). Following the explosion, the utility company shut off the natural gas supply at the meter and also pinched the plastic supply line 100 meters (300 ft.) upstream as an additional precaution (Figure 1d).

Figure 1: Damage to the hotel (1a, 1b, 1c). gas pinch point (1d)

This value is consistent with the damage observed to glass, drywall, sheet metal and light equipment. It is also consistent with damage in typical gas explosions as calculated in a CFD study (Pedersen and Middha, 2012). No damage was observed to the concrete slabs or the steel framing of the hotel.

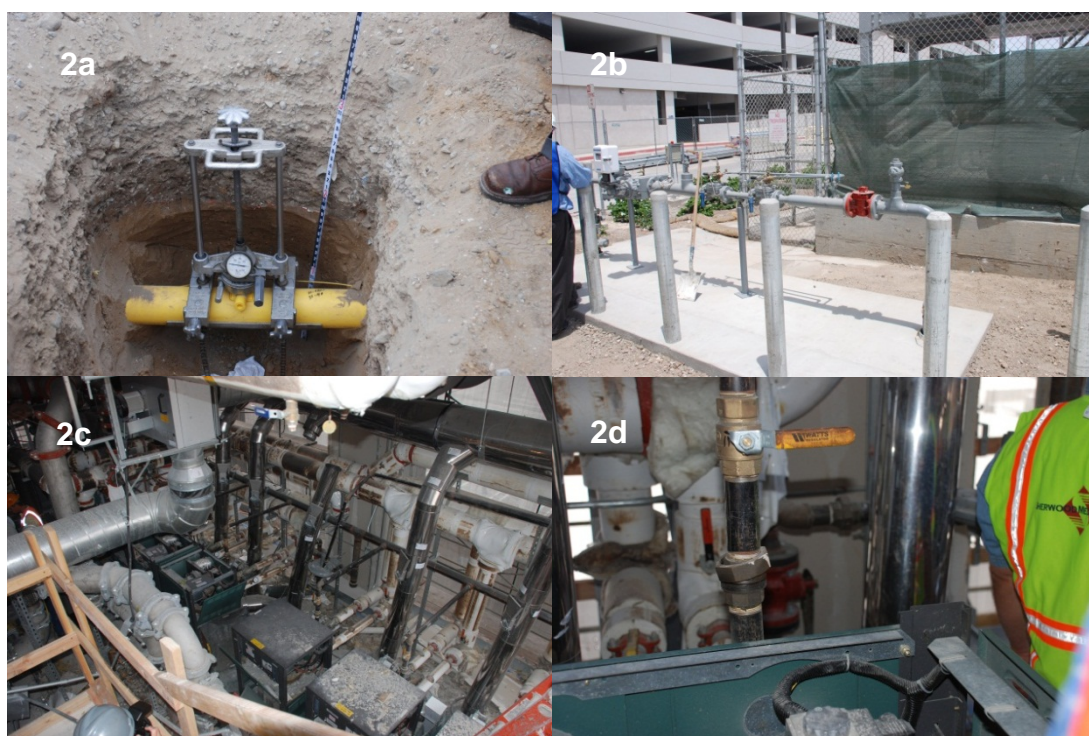
Natural gas is delivered to the site via a 10.2 cm (4 in), 308 kPa, absolute (30 psig) plastic pipe routed from the nearby convention centre (Figure 2a). The plastic pipe terminates at the meter set assembly (MSA) (Figure 2b). On the customer side, the pressure is regulated down to 136 kPa (5 psig), and a series of steel pipes deliver natural gas to various locations within the property. A 6.4 cm (2.5 in) line runs from the floor level to the fifth floor mechanical room supplying fuel to six Raypak water heaters. The pressure is then regulated to 103 kPa (8 inch-water), before it is supplied to a common 5.7 cm (2.25 in) manifold (Figure 2c). Each water boiler is fed via a 2.5 cm (1 in.) line with a ball valve and an electronic shutoff switch to prevent over pressurization (Figure 2d).

Figure 2: Gas delivery: incoming line (2a), meter set assembly (2b), 5<sup>th</sup> floor fuel manifold (2c), and water boiler feed (2d)

Exponent inspected the explosion site within one week of the explosion, after access was permitted by the Occupational Health and Safety Administration (OSHA), and the local fire department. Our investigation established that a coupling below the ball valve to a water boiler in the mechanical room had been disconnected (Figure 2d). This allowed natural gas to be directly released into the mechanical room when the valve was opened. Witnesses described that, just before the explosion, two plumbing contractors disconnected the coupling to purge the lines. The plumbing contractors also confirmed that they actuated the ball valve several times to purge the air in the line. A channel lock found on the floor behind the boilers is believed to be the tool used to disconnect the gas line coupling. Our review of the digital meter records established that 113.3 m<sup>3</sup> (4,000 ft<sup>3</sup>) of gas was supplied to the hotel between 13:00 and 14:00, just prior to the explosion. Review of work activities indicated that gas was not used anywhere else, confirming that this volume was released into the fifth floor mechanical room during the purging operation. Field tests

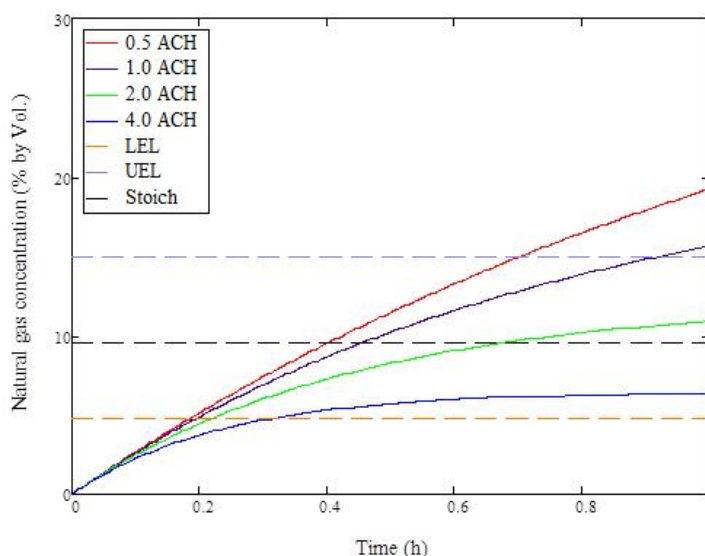
Where  $V_{total}$  is the effective volume of the fifth floor mechanical room (409.2 m<sup>3</sup>),  $Q_{gas}$  is the gas flow rate from our field experiments (0.031 m<sup>3</sup>/s), and  $Q_{air}$  is a parametric value for air exchange rate. Figure 3 shows gas concentration as a function of time and demonstrates that explosive limits were met during most of the purging operation.

Figure 3: Gas concentration in the mechanical room for various air exchange rates
