Explosion at a Hazardous Waste Site Caused by Contaminated Nitric Acid

Ivan Vince

ASK Consultants, 14 Scotts Avenue, Bromley BR2 0LQ, United Kingdom
ivince@askconsultants.com

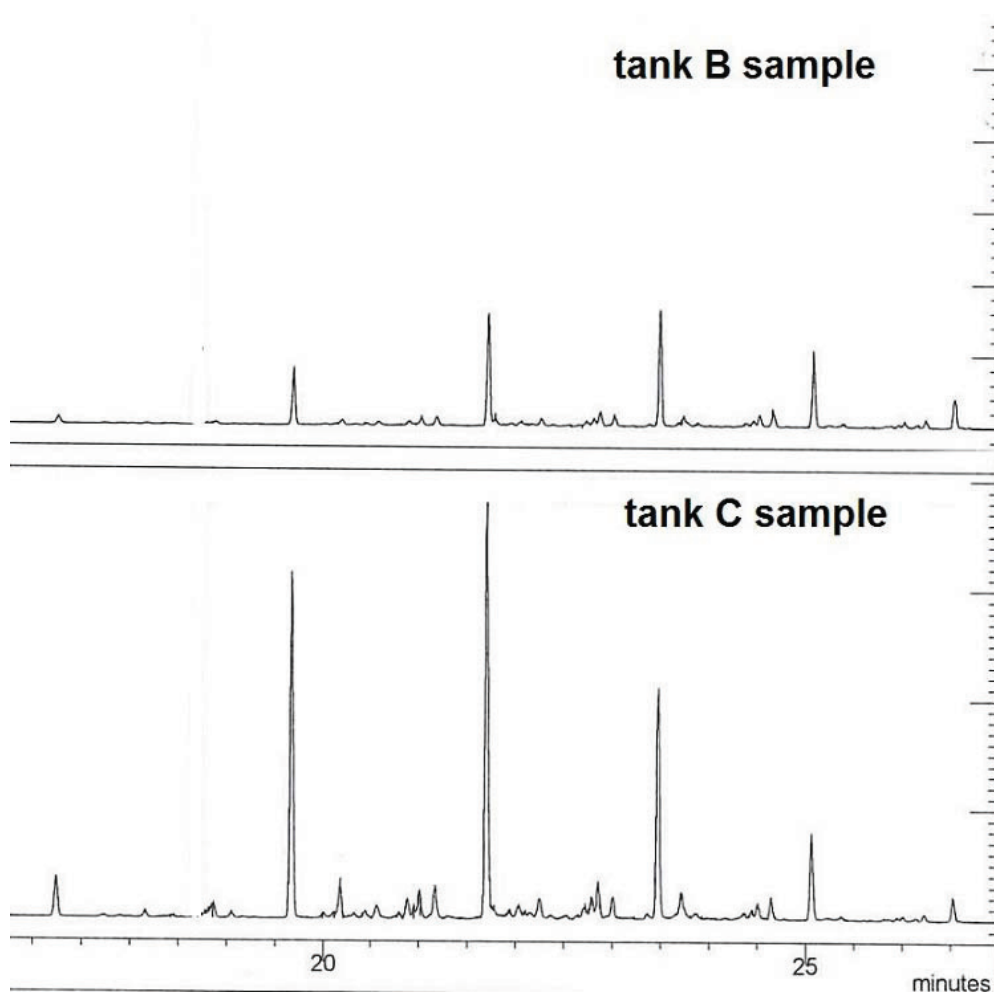
The tank B and tank C samples both had a distinct odour of white spirit. However, GCMS headspace analysis revealed important differences. The concentration of volatile organics was far higher in the tank C liquid than in tank B. More significantly, there was a shift in the distribution of individual components in the 'white spirit' in going from tank B to tank C, such that the latter corresponded to a more volatile liquid than the former – see Figure 1 below.

Figure 1: GCMS analysis of hydrocarbon components of organic layers from tanks B and C, showing 'centre of gravity' of peaks further to the left (increasing volatility) in the latter.

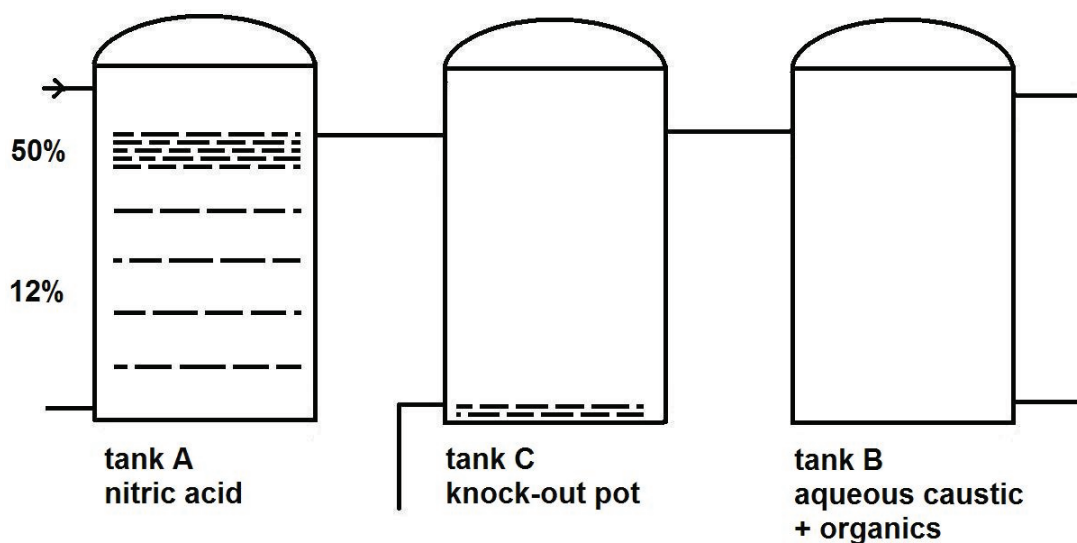
While the average concentration of nitric acid in tank A was approximately 12 %, the last two IBCs emptied into it had contained approximately 50 % nitric acid. Further, there is a strong possibility that the mixer in the tank was not running. Therefore, as depicted in Figure 2, the acid overflow from tank A is likely to have been much more concentrated than that of the tank inventory as a whole. This is significant because, while even 12 % nitric acid is a strong oxidising agent, the concentrated acid would have been capable of reacting, in the time available, with a far wider range of organic substances.

Figure 2: situation after draining nitric acid in tank C resulting from tank A overflow; note that residue in tank C is likely to have been concentrated – up to 50% nitric acid.

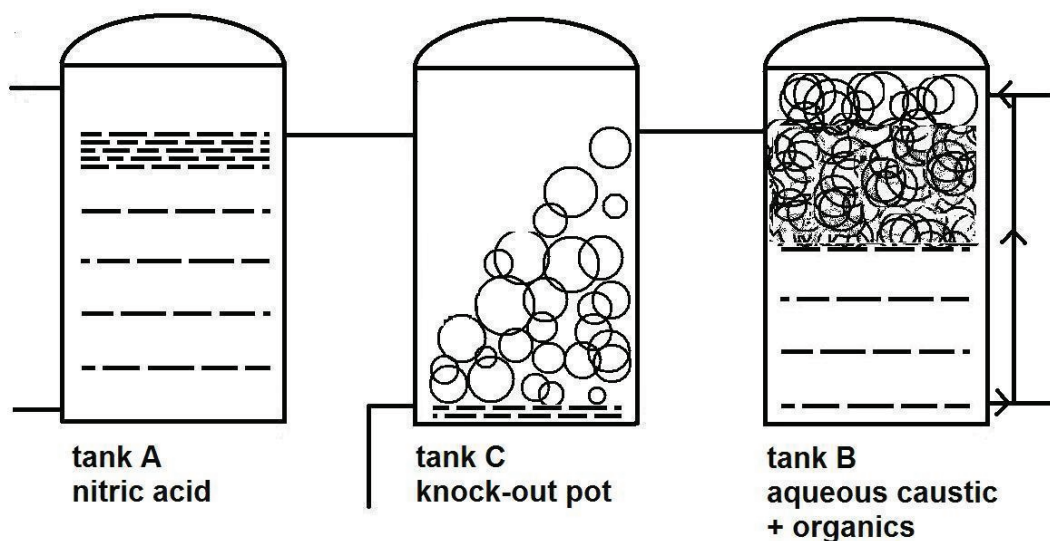
Although, as already mentioned, tank B is unlikely to have overflowed, conditions in the tank during recirculation (the tank B mixer was inoperative) favoured the generation of foam, which would readily have diffused into tank C (see Figure 3). Foaming, caused by splash filling and recirculation, would have been enhanced by the presence of detergents. Foam would not have been detected by the radar level gauge. Charging further liquid into tank B would have immediately displaced an equivalent volume of foam directly into tank C (Figure 4). Finally and significantly, unlike liquid overflow, foam carryover is consistent with the observed increase in volatility of the hydrocarbon fraction in going from tank B to tank C, noted above.

Figure 3: foam generated in tank B by splash filling and recirculation has migrated into tank C and come into contact with the nitric acid residue.

In the present instance, the operator had identified the potential hazards of allowing nitric acid to come into contact with organic wastes, and accordingly had ensured that there were dedicated vessels and pipework for each liquid stream. However, the operator had overlooked the possibility of airborne transfer of foam laden with organic material into the common knock-out vessel. The recommissioned unit has a separate knock-out vessel for nitric acid.

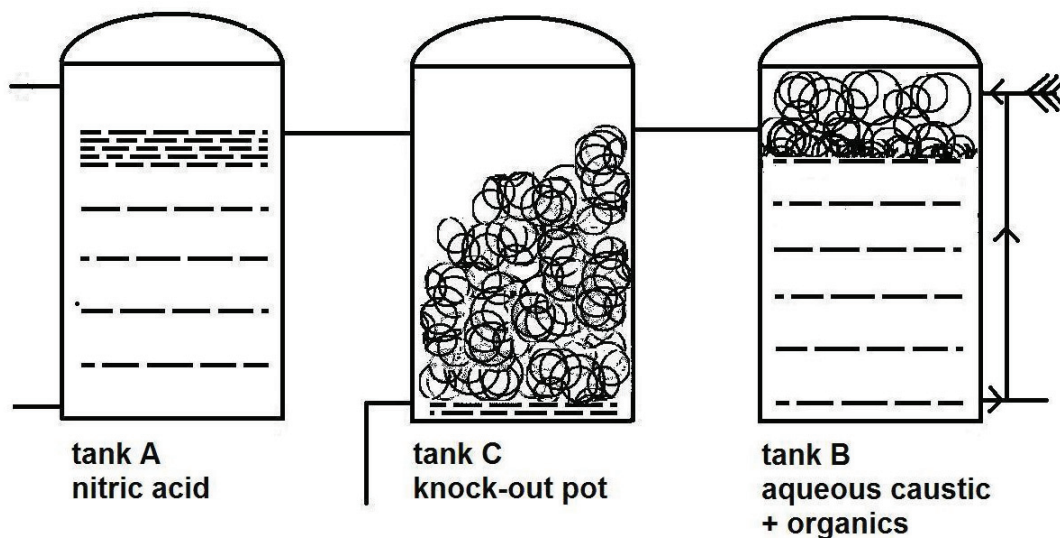
A plausible sequence of events is as follows. Besides the nitroaromatics detected, it appears likely that other, less stable nitro or nitrate compounds were formed at the same time. The tank was then drained. When pumping commenced from the road tanker into tank B, enough caustic foam would have been displaced into tank C to neutralise the acid residue, generating a substantial amount of heat, which could have been the trigger for an exothermic reaction, such as the decomposition of the unstable compound(s). The release of energy from this decomposition could have occurred explosively and/or it could have served to ignite the white spirit distillate vapour in the vessel.

Figure 4: fresh material pumped into tank B displaces a relatively large volume of foam, whose caustic component neutralises the acid residue and raises the temperature in tank C.
