Troubleshooting Distillation Columns Unexpected Causes for Malfunctioning Columns

Mario Roza, Markus Duss

Sulzer Chemtech Ltd, Winterthur, Switzerland
mario.roza@sulzer.com

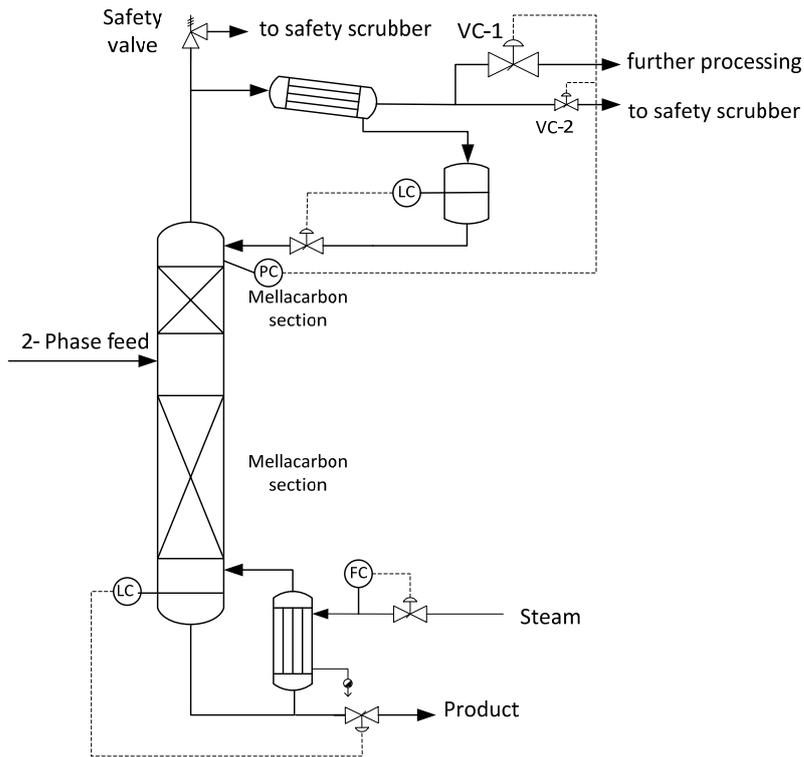
Figure 1: Simplified Process Flow Diagram of the high-pressure column

During the water test, the high-pressure column was started up by opening the steam valve to the reboiler manually with a fixed position. The control valves VC-1 and VC-2 remained closed in manual position, so inert gases in the column were trapped. The temperature of the column sump, filled with water, started to increase due to the steam supply. When the temperature exceeded 100°C, the pressure in the column started to

increase and at 160°C, the pressure was about 6 bar. At 6.5 bar pressure increase the safety valve, which was located up-stream of the condenser, opened. At this point in time the condenser had cooling water supply and was still cold. The inert gas could now leave the column through the safety valve and the inert gas, steam mixture was released through the safety scrubber. However, the condenser down-stream of the safety valve, still filled with trapped inert gas, remained cold. The pressure in the column remained rather stable around 6.5 bar while the safety valve opened and closed intermittently. Based on the DCS records the release through the safety valve continued for a few minutes. The noise of the chattering safety valve made the operators aware of the situation and the control valve to the atmospheric safety scrubber VC-2 was partially opened. Now the inert gas from the condenser was able to escape and inert and steam were released through VC-2 and the column pressure rapidly decreased. This rapid decrease in pressure was partly due to the steam leaving through the control valve but more importantly because of the high condensation rate, as pure steam has an excellent heat transfer coefficient and the temperature difference was high. Based on the recorded liquid level, the initially empty reflux tank was filled within a few seconds. Estimates of the condensation rate indicate that, during this short period, the F-factor must have been extremely high, exceeding 25 Pa^{0.5}. At this F-factor, the column was flooding and the pressure drop was so high, that the Mellacarbon packing was lifted up. This uplift might have additionally increased the pressure drop because loosened packing sheets reduced the free area for the gas flowing through the liquid distributors. Consequently, the column internals were also lifted and the observed damages could occur.

The control valve VC-2 to the safety scrubber was designed to restrict flow rates to avoid mechanical damage, even when fully opened. It was the condenser, performing much better than at design conditions, which caused the high F-factors and resulting damage to the internals. The condenser was designed to condense a relative small fraction of liquid from a gaseous phase. The design heat transfer coefficient was small and the transient situation, when pure steam entered a cold condenser, was not considered. To avoid the rapid pressure decrease at startup, the startup procedure was modified. Steam supply to the reboiler required now the pressure control valve VC-2 to be set to automatic mode and the position of the pressure control valve was limited to a minimum value allowing the inert gas to escape. Only when the overhead temperature of column exceeded 100°C, the limitation of the valve position was disabled.

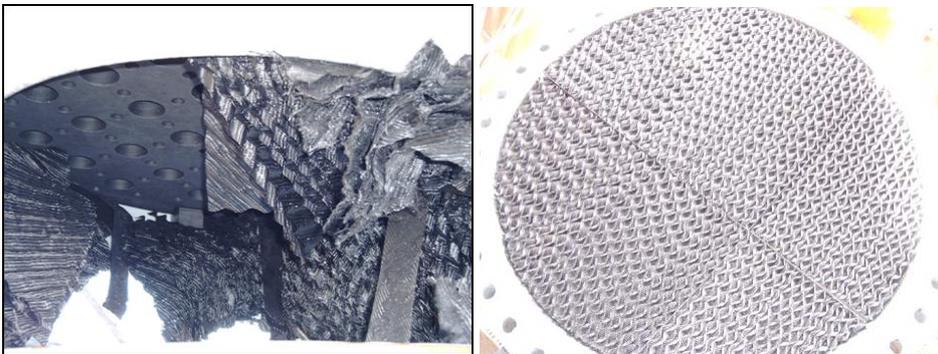
The inspection showed a lot of damage to the bottom carbon fiber bed and some of the graphite internals. The bottom support grid from graphite was broken, but it was still able to support the Mellacarbon packing. The lowest packing layer was destroyed and the 2nd layer was severely damaged. Furthermore, the top layer of the bottom bed was destroyed and the second layer damaged. The other layers were still intact. The liquid distributor, a chimney tray with ground holes made from graphite, did not have significant damage, but it had been lifted up and fallen back in position. Some Mellacarbon packing sheets were jammed between the support grid and the distributor, as can be seen in Figure 2. The upper Mellacarbon bed did not show any mechanical damage, however, the liquid distributor at the top had damaged gas raisers and the liquid feed pipe, guiding the reflux into the liquid distributor was torn and heavily damaged.

Figure 2: Left: Chimney tray made of graphite (view from below), with jammed Mellacarbon™ sheets; right: top layer of Mellacarbon™ of the upper section remained in place.

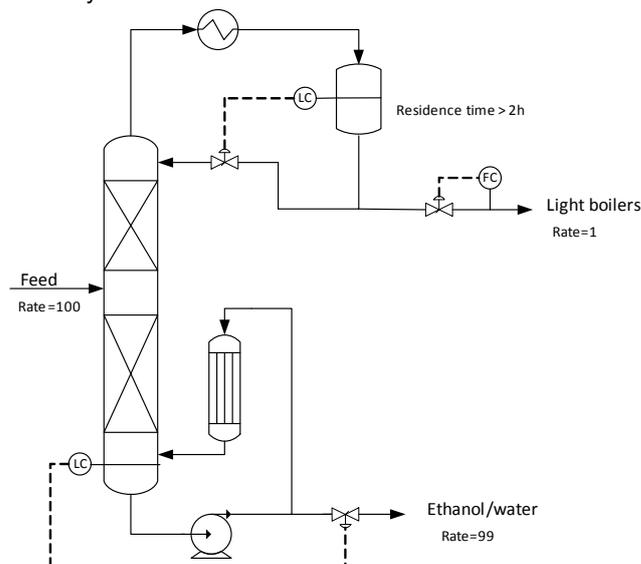
As mentioned before, the first column was fulfilling all expectations, but the second column (Figure 3) did not achieve its performance as expected. The acetaldehyde content was higher than expected and the specification could not be obtained constantly. Particularly, when the column was restarted after a cleaning cycle, the acetaldehyde content was particularly high in the bottom product and exceeded the specification significantly. Only after many hours of continuous operation, the acetaldehyde concentration reached its steady state, close to the required specification.

Figure 3: Simplified Process Flow Diagram of the second column, removing light boilers

Firstly, high residence time in the overhead system: the bleed stream at the top of the column was only about 1% of the feed stream. The overhead system consisted of a condenser with a reflux tank and reflux pump. The reflux was level controlled and the bleed stream was controlled by flow rate (Figure 3). Due to this small bleed stream rate, residence time in the column overhead system was more than 2 hours.

Based on the gained insight, the overall column performance could be significantly improved and the startup time after cleaning cycles reduced. Firstly, the liquid hold-up in the overhead system was reduced. Secondly, the residence time at the bottom was increased. This increased residence time was expected to have a positive effect since a low acetaldehyde concentration would shift the chemical equilibrium and diethyl acetal would decompose to form acetaldehyde, which could be removed from the bottom due to its high relative volatility. In this case, unfortunately not very elegantly, the only practical option to increase residence time was to increase the set point of the level control in the sump closer to the high level alarm.

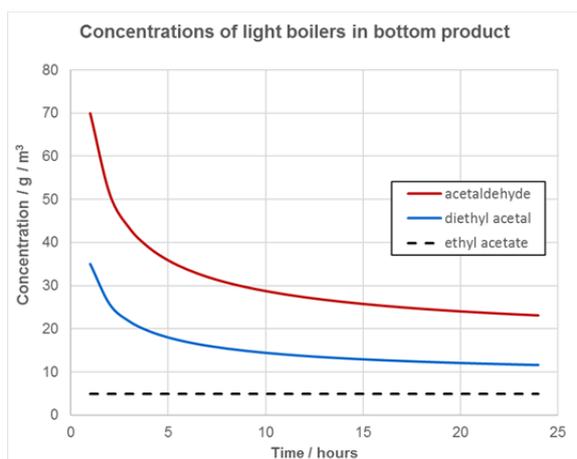
Figure 4: Time dependency of the concentration of relevant light boilers in bottom product stream as measured by the GC.

The results from the GC did not show any unexpected peaks beside acetaldehyde, ethyl acetate and diethyl acetal. However, the ethyl acetate concentration was stable after one hour of operation but acetaldehyde and diethyl acetal concentrations became only stable after about 24 hours. The initial high concentration of acetaldehyde and diethyl acetal in the bottom (main product) after startup was significant and exceeded the required specification by more than a factor of three. It was suspected that acetaldehyde and diethyl acetal underwent reactions during shut-down time. Question is now what reaction could cause that acetaldehyde and diethyl acetal showed such behavior? If acetaldehyde was reacting to form diethyl acetal, one would expect that the acetaldehyde content is low and vice versa, when acetaldehyde was formed from diethyl acetal, then it was expected to find a reduced acetal concentration in the bottom.

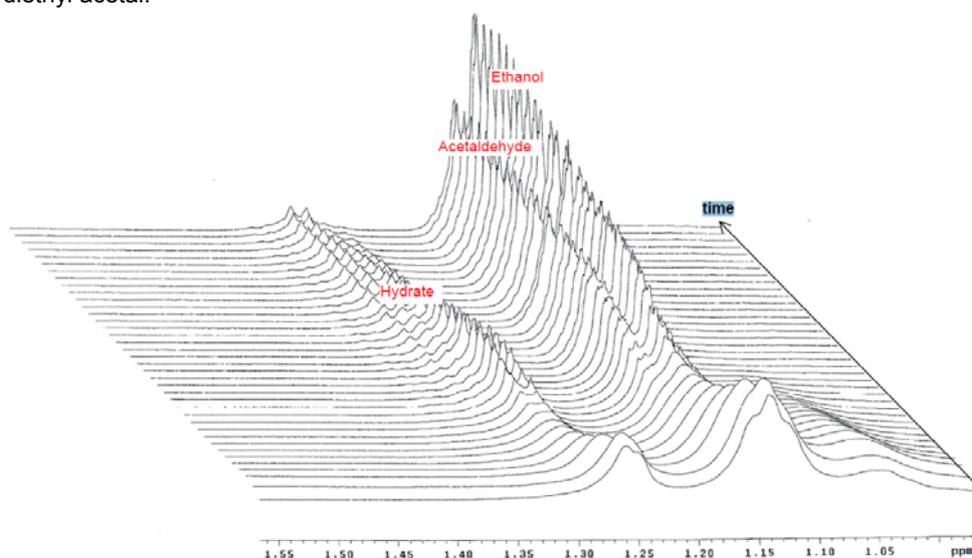
The formation of diethyl acetal came as a surprise since it was expected that the reaction occurred only in presence of acids (Vollhardt, 1990), which act as catalysts. To ensure the reaction takes place also in the presence of water only, the following test was carried out: Pure diethyl acetal was mixed with water, forming two liquid phases. The aqueous phase containing about 5% acetal was analyzed with NMR. The formation of acetaldehyde was monitored for two hours. It was found that the reaction is slow at 75°C . The concentration in acetaldehyde continuously increased, however equilibrium was not fully achieved after 2 hours. In addition, in a separate test it was shown that acetaldehyde mixed with pure ethanol only forms the hemiacetal and no diethyl acetal.

Figure 5: ^1H -NMR results showing formation of acetaldehyde and ethanol for a time span of 2 hours, starting from an aqueous phase saturated with diethyl acetal, with no initial ethanol or acetaldehyde.
