An Analysis of Severe Vapour Cloud Explosions and Detonations in the Process Industries

Geoffrey A. Chamberlain^a, Elaine Oran^b, Andrzej Pekalski^{c*}

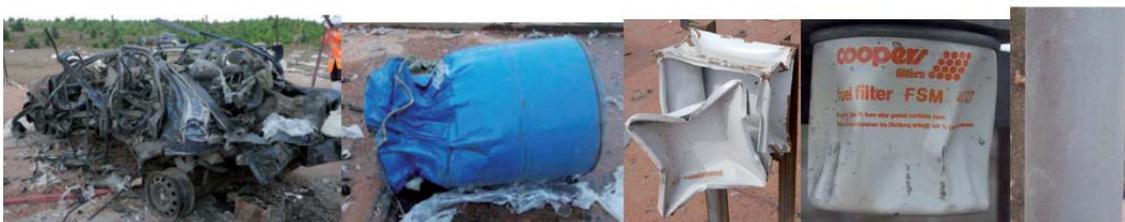
Figure 1: Damage to some of the items placed inside a propane detonation (Burgan, 2014). Damage created by overpressure > 10 bar. Note the dark markings on the post (extreme right) facing opposite to detonation propagation.

Table 1. Damage markers used as evidence of detonations as shown in Figure 1.

Item	Overpressure Required
Vehicle damage	> 10 bar
Tyres debeaded	> 8 bar
Oil drums	> 3 bar
Switch boxes	> 5 bar
Oil filters	> 10 bar
