Hazardous Spray Release from a Pipeline under Maintenance: Causes and Lessons Learned by a Combined Accident Analysis Perspective

Tomaso Vairo^{a*}, Stefania Magri^a, Andrea P. Reverberi^b, Bruno Fabiano^a

^a DICCA - Civil, Chemical and Environmental Engineering Department, Polytechnic School - Genoa University, via Opera Pia 15 - 16145 Genoa, Italy

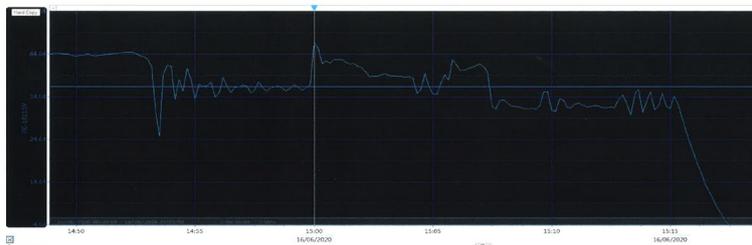
Figure 1: Pressure measurement charts.

Injection of nitrogen online must take place according to a two-batches procedure: the accident occurred after the introduction of the first batch when the nitrogen in the line was 16,054 Sm³. The operation involved the recording of data every 15 minutes and the passage of the PIG at the scheduled control points; the actual pressure measurements during the operation are displayed in Figure 1.

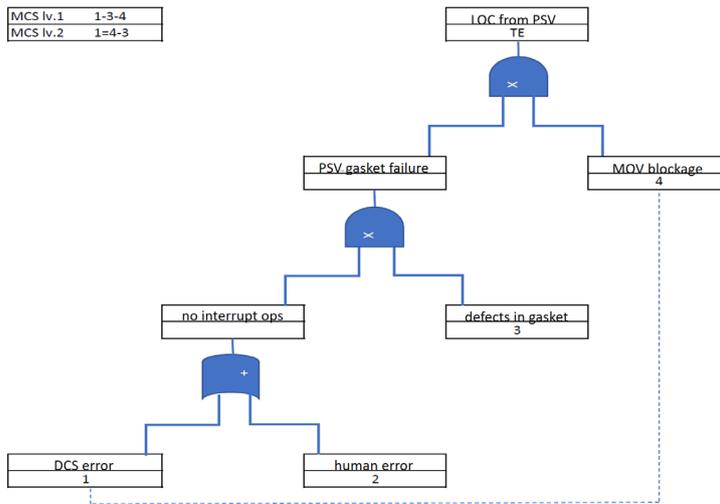
Figure 3: Fault Tree accident analysis.

The best approach lies in the systemic nature of the selected methods applied to the whole socio-technical hierarchy of the concerned process, trying to improve both existing hazard and accident analysis and evidencing possible safety constraints that were violated at each structure level. The schematic fault tree depicted in Figure3, allows identifying immediate and underlying causes, as follows. Malfunction of the flanged coupling due to improper tightening combined with imperfect assembly ("dirty" tightening) or a defect in the gasket.

- The positioning of the PSV and the atomization of the diesel fuel facilitated the extension of the leak outside the plant.
- The malfunction of MOV, which, at the reset command, does not open, causing the expected pressures to be exceeded with the consequent intervention of the PSV.
- Failure to remove the blocks caused the first interruption of the batching starting the incidental sequence.
- Failure of the actuator on MOV.

1. MCS level 1: 1-3-4. There was a signal error at the DCS. The MOV appears to be open, when it was closed. Due to defects in the spiral gasket of the PSV, the MOV still remains blocked close.
2. MCS level 2: 1=4-3. There was a signal error at the DCS. The MOV appears to be open, when it was actually closed. The wrong assumption forced the operator at the PIG sending station to try various restarts of the operation, with the MOV at the closed status.

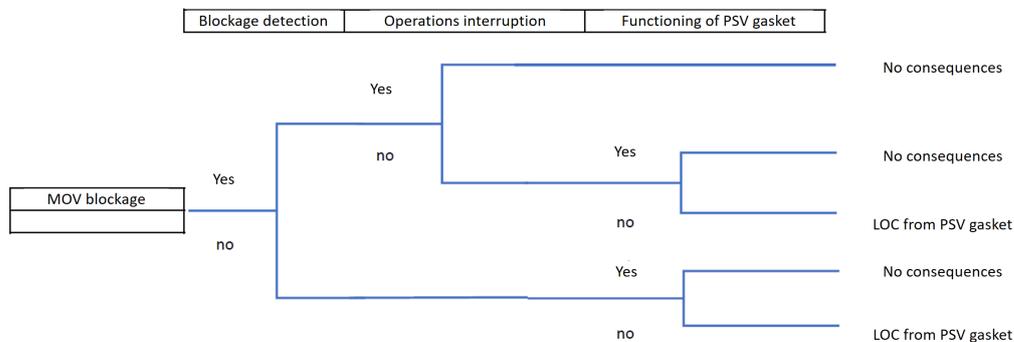
Figure 4: Event Tree consequence analysis.

A simple Event Tree Analysis was performed, tracing the event chain starting from MOV valve failure due to unscrewed actuator, as depicted in Figure 4.

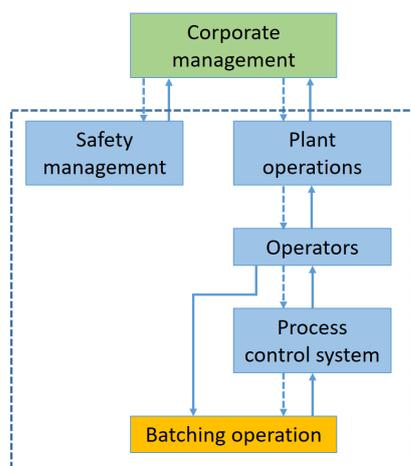
Figure 5: Safety control structure for the batching operation.

The role of technological and operational components, identified by the accidental sequences analysis and depicted in Figure 5, is crucial to better address the organizational and procedural improvement.

1. The signal of MOV valve closure was not reported in the control room, for a failure of the actuator.
2. The PSV gasket fails.

1. The pressure exceeds tier 1. The control on pressure works, the process is blocked by MOV closure.
2. After the block for high pressure, the operator at the starting station resets the operation by opening the MOV again. At DCS the MOV appears open, and the operator restart the batching.
3. The MOV is actually closed, so the pressure exceeds tier 1 again and the process is blocked again.
4. The operator reset and restart the process for the second time. The MOV actually remains closed. The pressure exceeds tier 2, and the PSV intervenes.
5. The PSV gasket is damaged. Instead transferring the product to the proper tank, a loss of containment from the PSV gasket happened.

1. There was an inadequate number of sensors at the MOV valve. The sensor was on the actuator, and not on the gate, which would have avoided the signal error following the unscrewing of the actuator.
2. The operator at sending station did not communicate with the operator at receiving station, who could have checked the status of the MOV.

1. Improve the signal reports at DCS by inserting an additional sensor on the MOV gate.
2. Define procedures for the communications between operators at different stations.
