Experimental Evidences in Bearing Diagnostics for Traction System of High Speed Trains

Paolo Pennacchi, Steven Chatterton*, Andrea Vania, Roberto Ricci, Pietro Borghesani

Politecnico di Milano, Department of Mechanical Engineering, Via G. La Masa 1, I-20156 Milano,
steven.chatterton@polimi.it

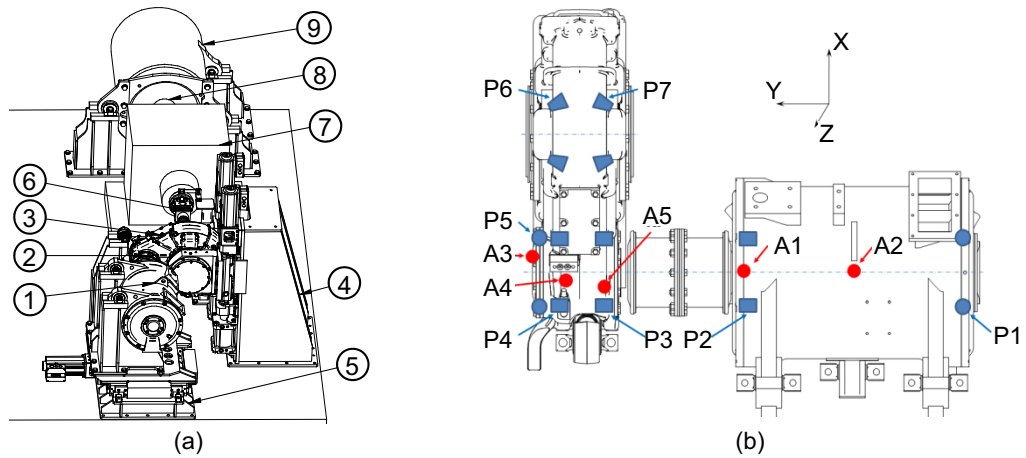
Figure 1: (a) Test-rig layout. ① HST motor, ② HST toothed coupling, ③ HST gearbox, ④ Vertical moving platform, ⑤ Horizontal moving platform, ⑥ Double cardan shaft, ⑦ Additional industrial gearbox, ⑧ Double cardan shaft, ⑨ Braking motor; (b) Traction system arrangement with bearing position (from P1 to P7) and accelerometer position (from A1 to A5)

Figure 1(b) shows the HST traction system along with the number, the position and the type of installed bearings. The motor shaft is supported by two REBs: the non driven end (NDE) side of the shaft is supported by a single row ball bearing, whereas that placed at the driven end (DE) side (P2) is a single row cylindrical roller bearing. Both bearings are lubricated with grease. The two helical gears of the gearbox are supported by 5 oil-lubricated bearings. Two cylindrical roller bearings (P3 and P4) support the input shaft, while an additional four-points ball bearing (P5) bears the axial force caused by the helical gears. The wheel axle is supported by two tapered roller bearings (P6 and P7). The test-rig was equipped by several accelerometers located in different positions of the traction system. The vibration signals were acquired by a Data Acquisition System (DASY) which is composed of a National Instruments PXI module placed in the test-rig room and connected to a remote desktop PC by means of a fiber-optic cable able to convey a large amount of data with a high sample frequency, that was set to 20 kHz.

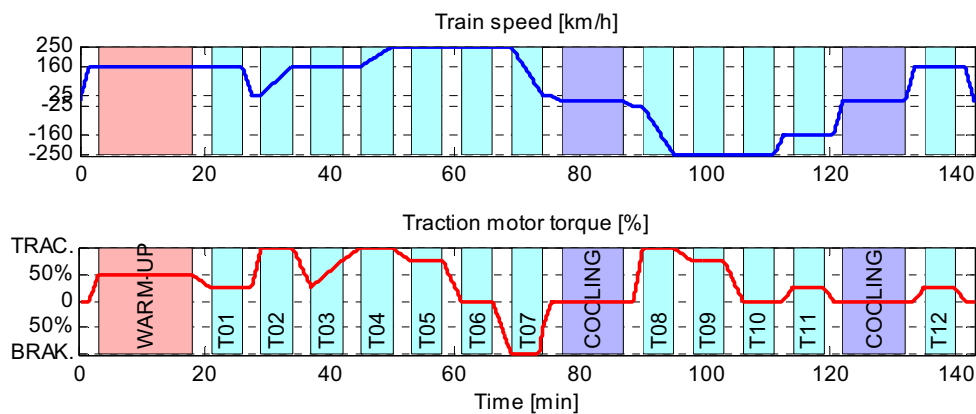
Figure 2: Operating conditions (train speed and motor torque)

A batch of experimental tests was performed for each configuration or set of bearings (i.e. combination of new or worn bearings in positions Pn), during the experimental campaign. The batch was composed of tests at different conditions of train speed and traction motor torque, in order to consider a wide range of train operating conditions (i.e. acceleration, braking and cruise). Therefore, each set of bearings was tested by following the scheme shown in Figure 2.

All the batches of the experimental campaign started with a warm-up phase, performed at 160 km/h and at 50 % of relative motor torque, in order to have the same operating conditions and to reach an adequate lubricant temperature. The warm-up phase was followed by a series of 12 tests T_m at different operating points. Each test lasted 300 s, during which DASY acquired data for 180 s. Moreover, 2 cooling rests of 10 minutes were set between test T7 and T8 and between test T11 and T12, when the rotation direction is inverted. Furthermore, test T12 is a check test, with the same parameters of test T1. For the sake of brevity, the results obtained for all the tests of a certain configuration of bearings will not be discussed: only the signals measured during the final test (i.e. T12) will be reported in the following, which operating parameters are listed in Table 1.

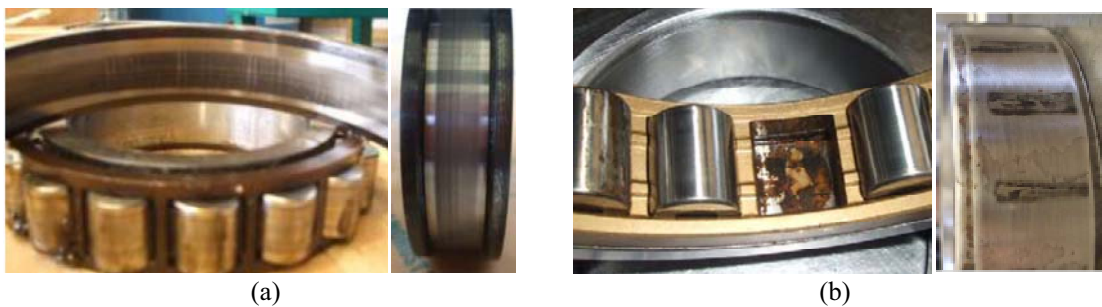
Figure 3: Cylindrical roller bearings taken from the service: (a) configuration ① - bearing at the DE side of the traction motor; (b) configuration ② - bearing at the high speed shaft of the HST gearbox.

- a) Configuration ①: worn roller bearing for the DE side of the motor (Figure 3(a));
- b) Configuration ②: worn roller bearing for the DE side of the gearbox high speed shaft (Figure 3(b)).

The cylindrical roller bearing taken from the service and supporting the HST motor shaft on the DE side is shown in Figure 3(a). The cage and the rolling elements are clearly visible in Figure 3(a); it is also possible to see the small amount of grease on the rolling elements. Therefore, the condition of reduced lubrication can be assumed. Moreover, the rolling elements are characterized by circumferential lines indicating bearing wear. The raceway of the outer ring is characterized by localized signs, which are likely due to localized spalling.

The second case considers a cylindrical roller bearing supporting the high speed shaft of the gearbox. The worn bearing, taken from the service, is shown in Figure 3(b). Oxidation of the bearing components has been detected during the inspection performed after the batch of tests. Also in this case the oxidation may be due to oil contamination.

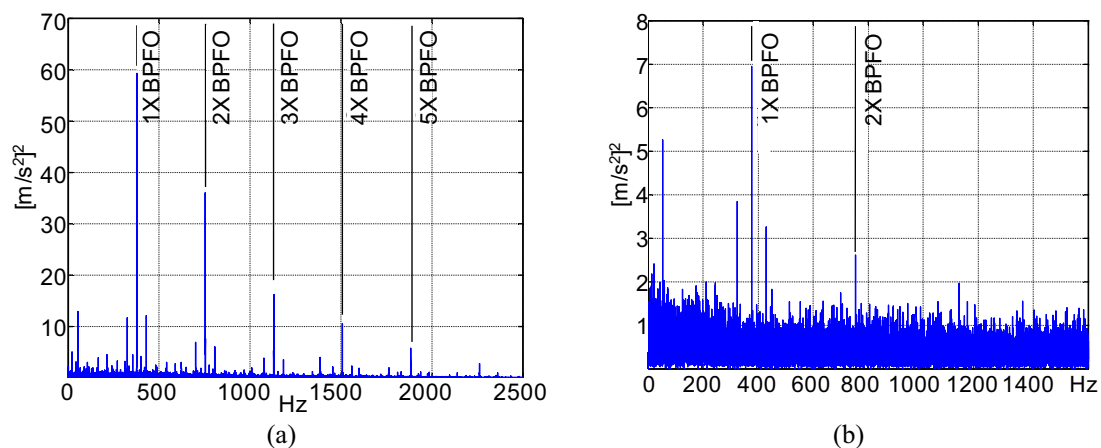
Figure 4: Spectral kurtosis results for vibration signals of configuration ① measured along x direction by (a) accelerometer A1 placed close to the bearing and (b) accelerometer A2 placed on the case of the motor

The application of SK to the signal measured by sensor A1 (Figure 4(a)) for the damage configuration ① allows highlighting the first 5 harmonics of the ball passing frequency on the outer ring (theoretical BPFO = 381 Hz), each of them characterized by the presence of sidebands spaced by the cage or fundamental train frequency (theoretical FTF = 22.4 Hz). These harmonic components clearly indicate the presence of damages on the outer ring of the bearing: the high number of harmonics and the presence of FTF sidebands suggest that outer race is damaged in many points: this is actually the effect of an impulse train. The results are not so clear for sensor A2 placed on the motor case. Figure 4(b) shows that the only relevant components in the SK analysis are 1X and 2X of BPFO. Sidebands are evident only for 1X of BPFO. The difficulty of diagnosing the damage can be ascribed in this case to the position of the accelerometer.

For the considered traction system, the diagnosis of bearing motor is possible by using sensors installed close to the bearing, even if not necessarily in the load direction (the horizontal x direction was used). This is relevant because motor installation in the bogie is rather cramped and sensors have also to be protected by accidental impacts of stones or objects, therefore sensor position could be often selected on the simple basis of space for its safe mounting.

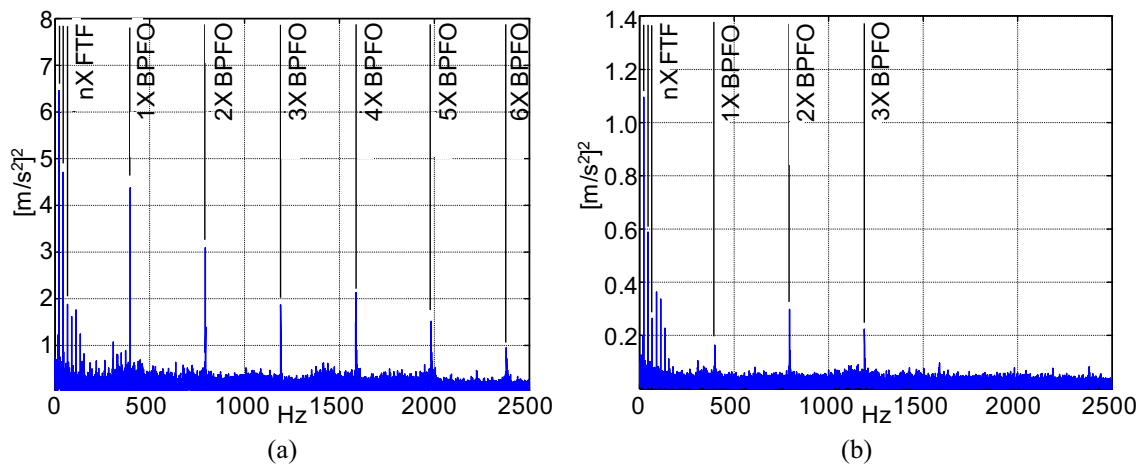
Figure 5: Spectral Kurtosis results for vibration signals of configurations @ measured along z direction by (a) accelerometer A5 placed close to the bearing and (b) accelerometer A4 placed far from the bearing

The vibration signals were acquired along the z direction by the tri-axial accelerometer A5, placed on the case of the gearbox close to the bearing, and by the tri-axial accelerometer A4, placed on the case of the gearbox far from the bearing. Figure 5 shows the results of the application of SK for the raw signals of the two accelerometers. SK analysis highlights the first 3 harmonics of the cage rotation (FTF = 22.6 Hz) and the first 6 harmonics of the frequency of the passage of rolling elements on the outer ring (BPFO = 400 Hz) for accelerometer A5 (Figure 5(a)). In this case, the components related to the motion of the train of rolling elements dominate SK frequency distribution, conversely from the oxidation on the ball bearing of case ②. Similar results are obtained for accelerometer A4 (Figure 5(b)), but only with the first three harmonics of BPFO. The reduction of the energy related to both the FTF and the BPFO harmonics, with respect to the accelerometer A5, is probably due to the fact that the sensor is far from the bearing in this case.

Results of this and previous section prove that the diagnosis of bearing faults on the gearbox of this traction system is possible even using an accelerometer installed far from the bearings. This suggests that a reduced number of sensors can be used on the gearbox.
