# Aging Equipment in Facilities and Daily Maintenance – Latent Risks on Sites with Major-accident Hazards acc. Directive 2012/18/EU

**Rainer Semmler**

TÜV SÜD Chemie Service GmbH, Industriepark Höchst, Geb. B 598, 65926 Frankfurt am Main, Germany  
[rainer.semmler@tuev-sued.de](mailto:rainer.semmler@tuev-sued.de)

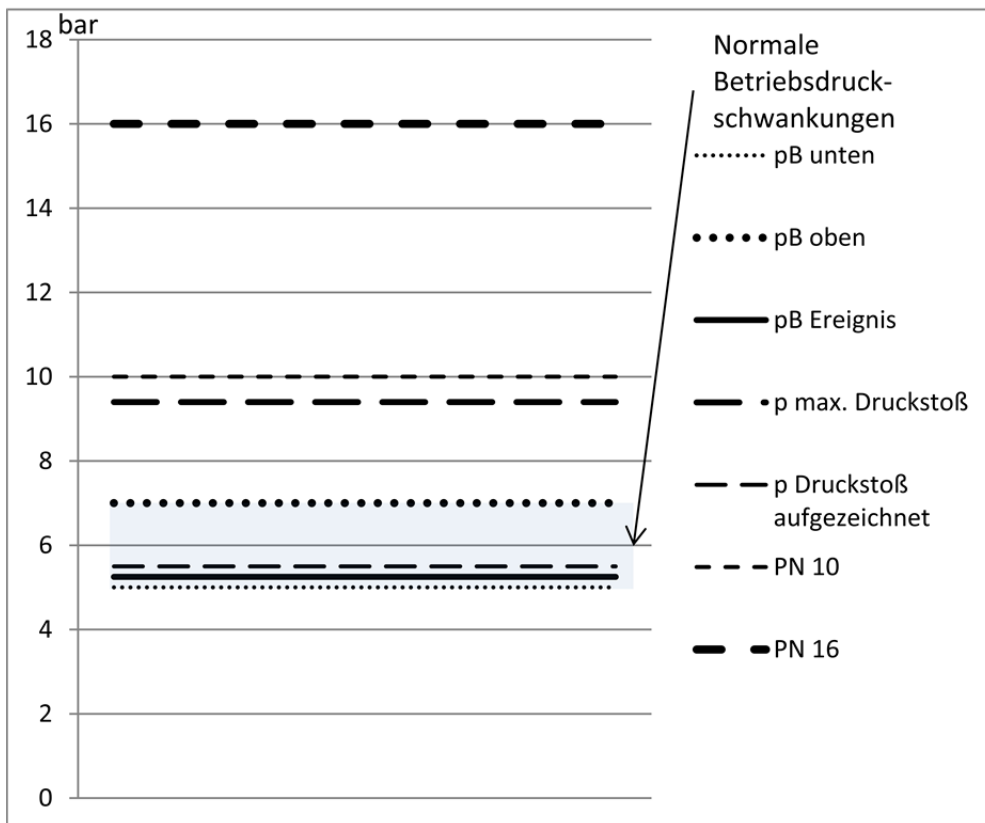
Figure 1: Shows different pressure levels. The lines “PN10” and “PN16” are allowable pressure for 2 different pipe classes. The lines “pB unten” and “pB oben” indicate the pressure range of the operating cooling water system. “pB Ereignis”: Operating pressure before the incident. “p Druckstoß..”: Pressure level of water hammer due to pressure reading with low resolution. “p max. Druckstoß”: Calculated pressure level of water hammer.

At a major industrial chemical park, a main cooling water pipeline (nominal width 1000 – 1400 mm) caused a Joukowski water hammer which led subsequently to the integrity loss of several smaller cooling water pipelines in the basement of a production building, resulting in flooding the entire basement and emergency shutdown of the process plant due to short circuits and water induced failures in instrumentation and control equipment.

It's common knowledge, that closing a valve can cause a Joukowski water hammer depending on the closing velocity of the valve and the impulse of the media in the pipeline. But, what else can cause it, if you can exclude valves, pumps or collapsing big gas / vapour cavities as a root cause?

In the analysis we found, that the main cooling water pipeline was over 40 years old. The pipeline was manufactured from steel with a concrete liner. Occasionally the operator found some thin concrete pieces in the cooling tower and wondered, where they might come from because it's a closed cooling water system and there was no information available about construction works with concrete. Following the analysis due to the age of the pipeline there was internal corrosion which led to a local separation of the concrete liner from the steel pipeline. The separation could lead to small concrete piece or even big pieces. In the considered case a big piece of the concrete liner blocked the pipeline at a smaller diameter internally of a valve. The thin piece of the concrete liner couldn't withstand the impulse of the moving water mass and was destroyed immediately. But finally this short blockage of the pipeline caused a Joukowski water hammer which was confirmed by a simulation calculation and comparison with the pressure readings. When the results of the Joukowski water hammer calculations and pressure readings have been analyzed an additional cause was found (see figure 1 and 2). The maximum calculated pressure level of the Joukowski water hammer is lower than the allowable pressure for the pipeline classes which have been used for downstream cooling water supply in the production building and they could only fail with regard to wall thickness reduction caused by corrosion.

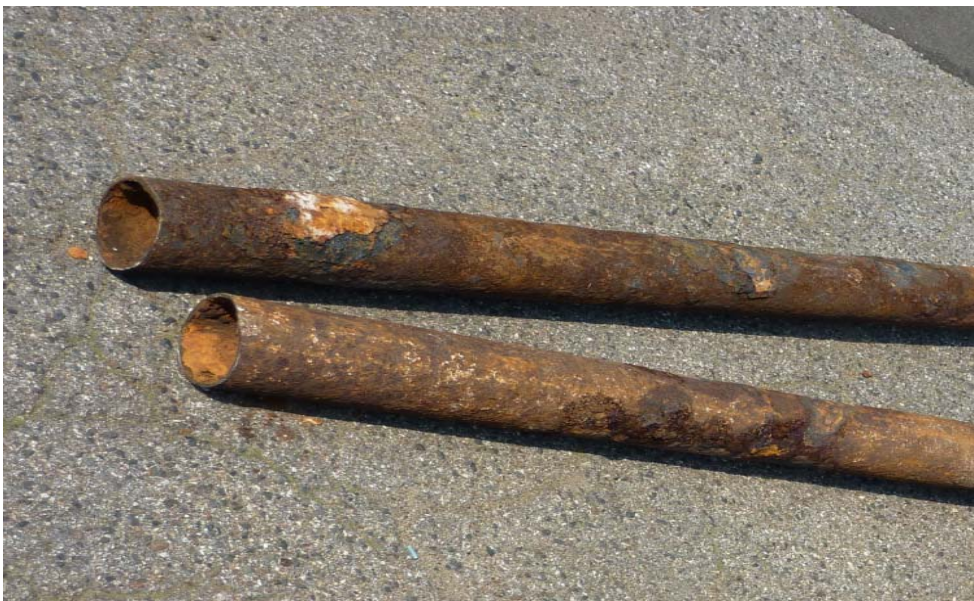
Figure 2: Samples of downstream cooling water pipelines in the production building showing significant corrosion and reduction of wall thickness.

Before the incident, no visual inspection program of the cooling water pipelines has been in place due to their polyurethane foam coating for insulation and the extensive effort for inspection for corrosion under insulation or wall thickness measurements.

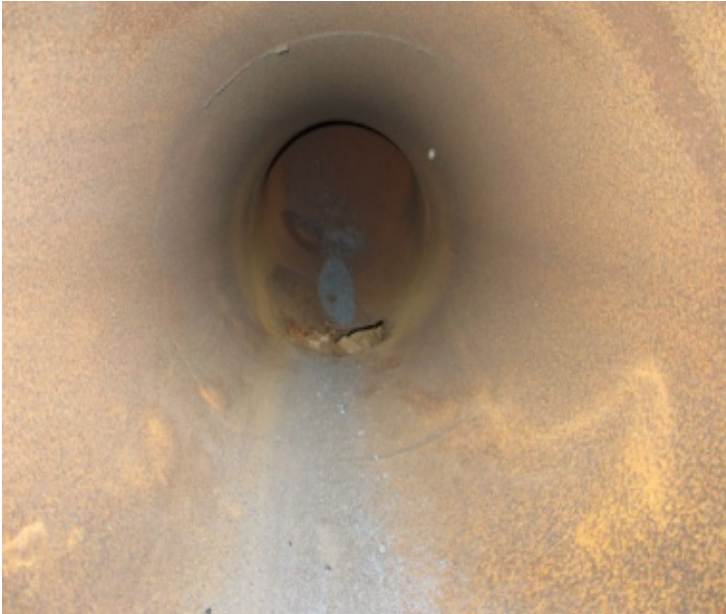
Figure 3: View in the main pressurized air pipeline

The following example shows a main pressurized air pipeline right behind the compressor leaving the compressor building. Due to condensates at lowest point (pipeline bend), corrosion was induced and reduced the wall thickness over time (figure 3 and 4). The underground pipeline was not periodically inspected and an inspection even not considered, because of an air drying step right after the compressor. The pipeline itself is crossing a interplant traffic way for people and vehicles. The compressor building is located close to production plants and the explosion crater close to / partially in the traffic area (figure 5 and 6). The explosion crater caused some minor damages to the grounding and settlements of the compressor building. In case of traffic major injuries would be the result. If the incident area would have been closer to a production plant the blast and debris could have led to a significant impact.

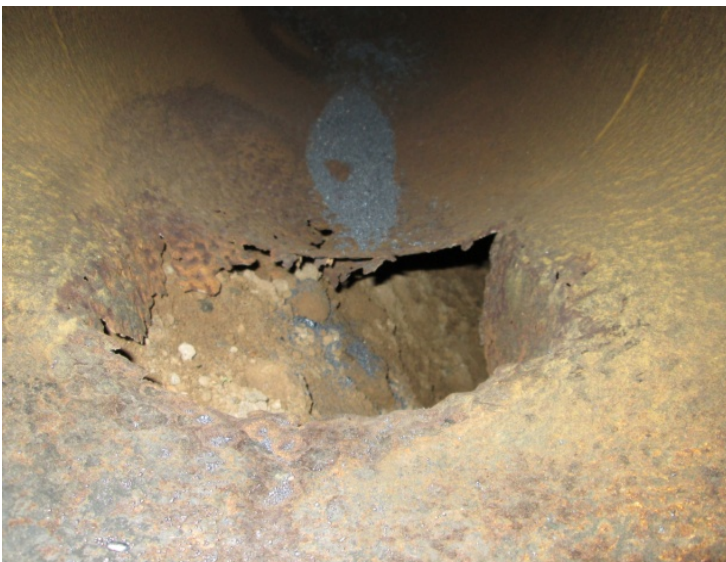
Figure 4: Detail view on the corroded area

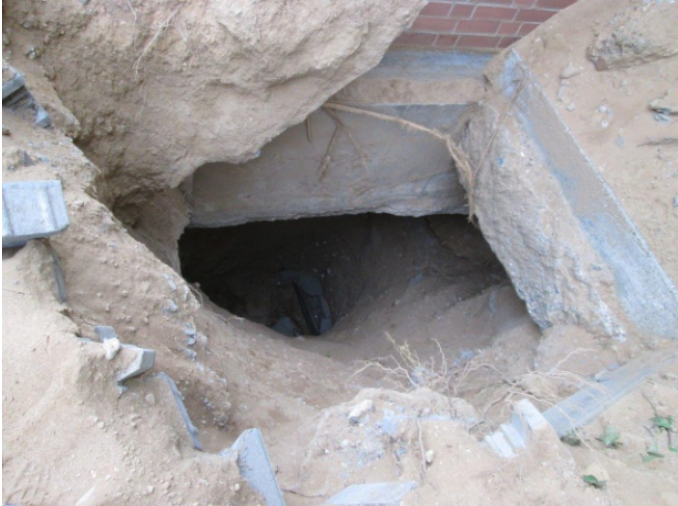
*Figure 5: Detail view on the explosion crater*

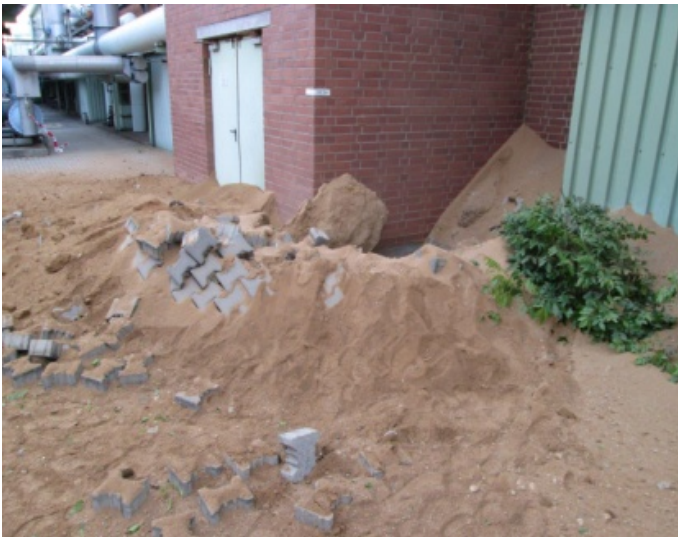
*Figure 6: Close environment of the explosion crater*

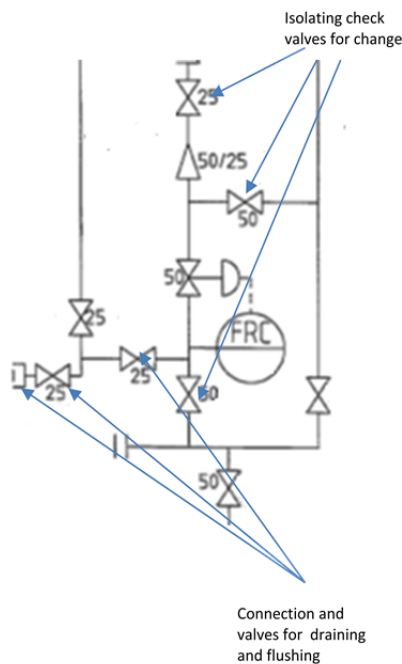
Figure 7: Sketch of the considered installation of the control valve

The change of a traced control valve is a routine daily maintenance task, managed via work permit system and following line breaking procedures, especially if the design is according state of the art (figure 7). In this specific case the pipelines and valves have been traced (approx. 150°C) because the acid product will solidify at ambient temperatures. The control valve is a failsafe close type, which closes when power is disconnected. The tracing was still in place when the operators started with draining and flushing, disconnecting the power supply to the control valve. In sequence, when the power was disconnected, pressure built up in the blocked intake segment of the pipeline, which is opposite of the control valve with no connection to the drain / flush line, and accidentally released as a vapour blast together with residual acid liquid. The range of the vapour blast was about 5-6m. Two employees wearing the required personal protective equipment (operator: full body chemical protection suit, helmet and face shield. Supervisor in approx. 6 m distance: Helmet and safety glasses, working garment with limited, temporary chemical protection) have been hurt (temporary eye and face/throat chemical burn requiring medical treatment in hospital). In the hazard analysis for the work place as well as in the safety analysis the replacement of valves has been considered in general, work permit system and line breaking procedures have been followed. The weak point was that not all valves are of the same failsafe type, what might lead to a specific hazard.
