Groundwater and Leachate Quality Assessment in Balaoan Sanitary Landfill in La Union, Northern Philippines

Mario B. Mendoza, Leonora E. Ngilangil*, Desiree A. Vilar

Don Mariano Marcos Memorial State University, Bacnotan, La Union, Philippines
 lengilangil@gmail.com

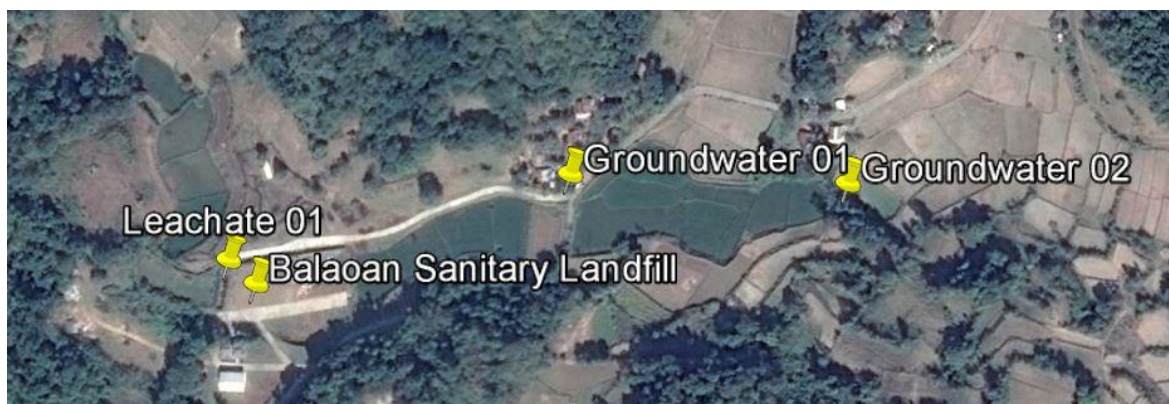
Figure 1: A view of the sanitary landfill showing the groundwater sampling sites.

With a total land area of about 6,870 hectares (17,000 acres), the municipality of Balaoan consists mostly of agricultural lands. With geographical coordinates of 16°19' 30" N latitude and 120°22' 7" E longitude, the municipality generates about 25.5 cubic meters of wastes per day. The bulk of the wastes being collected consist of organics and inorganics, segregated at source and transported to barangay Calumbuyan where the facility is located. The Balaoan sanitary landfill (Figure 1) has a total land area of one hectare with leachate pond situated at 16°48' 42.9" N latitude and 120°23' 21.2" E longitude, with an elevation of 68 m.

Two stations were selected within the 500 m radius near the study area during the months of February and April. The first station (GW1) was a tube well from a residence nearby located at 16°48' 45.2" N latitude and 120°23' 21.2" E longitude while the second groundwater station (GW2) was obtained from a constructed shallow well located at 16°48' 44.3" N latitude and 120°23' 35.9" E longitude. Grab method was used in the gathering of water samples and these were placed in plastic and sterilized containers, properly sealed and labelled, preserved with ice at lower temperature inside coolers for storage and transported to the laboratory for analysis. The groundwater samples were analysed in terms of physical, chemical and biological parameters such as pH, temperature, turbidity, conductivity, total dissolved solids (TDS), nitrates, total nitrogen, total phosphorous, total coliforms and fecal coliforms following the APHA-AWWA-WPCF (1994). The pH was measured using a calibrated pH meter and a glass electrode while the conductivity was measured following the gravimetric method. Turbidity was measured using the turbidimeter while nitrate was analysed using the Cadmium Reduction method. Total nitrogen and total phosphorous were measured using the Total Kjeldahl Nitrogen and the colorimetric method, respectively. The test results of the groundwater samples were compared with the standards set by the Department of Health (DOH) Administrative Order No. 2007-0012 or the Philippine National Standards for Drinking Water (PNSDW) and the World Health Organization (WHO) Guidelines for Drinking Water of 1997.
