# Investigation and Analysis of an Explosion at the GOEX Black Powder Manufacturing Facility

Ali Reza<sup>\*a</sup>, Zuhair Ibrahim<sup>a</sup>, Tim Vaitekunas<sup>b</sup>

<sup>a</sup>Exponent, Inc., 5401 McConnell Ave, Los Angeles, CA, USA

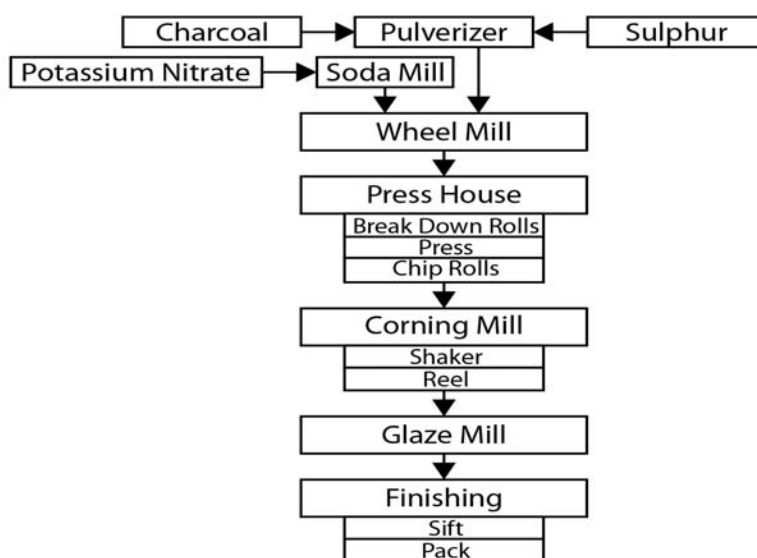
Figure 1: Goex manufacturing process

At the Goex Minden plant, black powder is manufactured following a process of 1) pulverizing/mixing, 2) milling/incorporating, 3) pressing, 4) corning/granulating, and 5) glazing/finishing (Figure 1, Goex, 2008). The raw materials are received in truck quantities and stored in super sacks. Batches of charcoal and sulphur (1,300 to 2,960 kg) are ground or pulverized in large ball mills and packaged into 13 to 16.5 kg bags. Although there is no explosion hazard during this step, the charcoal-sulphur mixture is combustible, and the high heat of hydration of charcoal creates the potential hazard of a hot spot causing subsequent ignition if the mixture gets wet at this stage. The prilled potassium nitrate is packed in 25 or 28 kg bags and stored separately. In the next step, all ingredients are further ground in remotely operated 250t (approximately 225,000 kg) wheel mills that incorporate (or mill) these ingredients together. A controlled amount of water is introduced to prevent accidental ignition of the explosive mixture during the milling process. The operators rely upon experience and their observations of the appearance and consistency of the mix to ensure that the product is not too wet for the next step and yet does not present ignition hazard. In this context, a prolonged loss of electrical power is especially hazardous because it can dry out the mix and create a hazard during the restart operation. After the milling is complete, the operators use conductive plastic shovels to transfer the wet product into bags. Goex pays particular attention to preventing stray ignition sources (including static sparks and frictional heating) at this stage, and employees are protected by appropriate Personal Protective Equipment (PPE).
