Protection Systems of Multirole Jet Aircraft System

Jarosław Bartoszewicz*, Adam Rojewski, Rafał Urbaniak

Poznan University of Technology, Faculty of Machines and Transportation, Chair of Thermal Engineering, pl. M. Skłodowska-Curie 5, 60-965 Poznan, Poland jaroslaw.bartoszewicz@put.poznan.pl

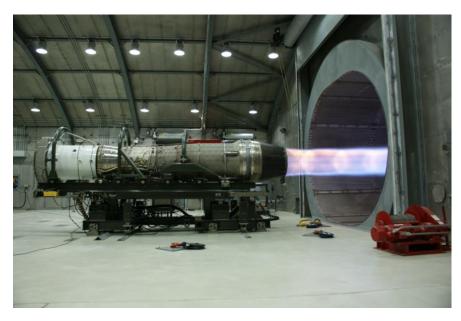
Figure 1: Hush house of 31st Tactical Air Base in Krzesiny

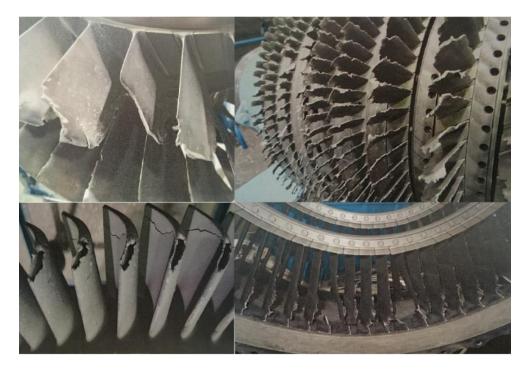
Figure 2: Damaged blades of the RD-33s compressor

First hazardous situation is FOD (foreign object damage). FOD mostly damages compressor blades. Figure 2 presents photos of jet engine RD-33s blades damage (Bartoszewicz, 2016), and Figure 3 presents compressor blade after repair. Compressor blade is often grinded, or changed for new one.

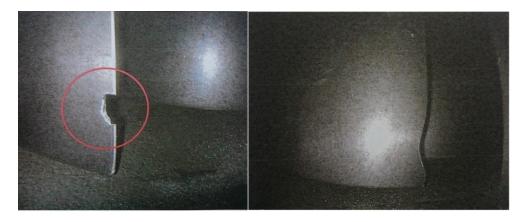
Figure 3: Compressor blade before and after repair (grinding)

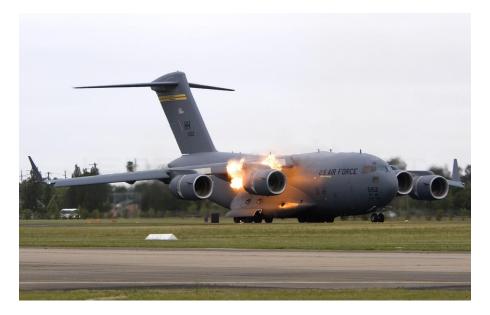
Figure 4: Engine compressor stall (Mallinson, 2006)

Engine stall (Bartoszewicz et al., 2014) may occur when the engine rpm is stabilizing within any range or when the throttle is being advanced to the Intermediate Power position or the Full Augmentation position. Stall may be accompanied by the noise coming from the engine. It usually disappears automatically. If stall lasts we deal with the stagnation, which is characterized by the growth of the FTIT and the decrease of rpm, or by the growth of the FTIT while rpm is below 60 %. In both cases the engine does not respond to the throttle's movements; however sound effects do not have to occur. When this defect is found, the throttle should be advanced to the Intermediate Power position, and when the stall disappears, the engine should be shut down.
