Lamb Wave Ultrasonic System for Active Mode Damage Detection in Composite Materials

Lorenzo Capineri^a, Andrea Bulletti^a, Marco Calzolari^a, Daniele Francesconi^b

1. Piezopolymer transducer network for damage detection on a COPV test sample

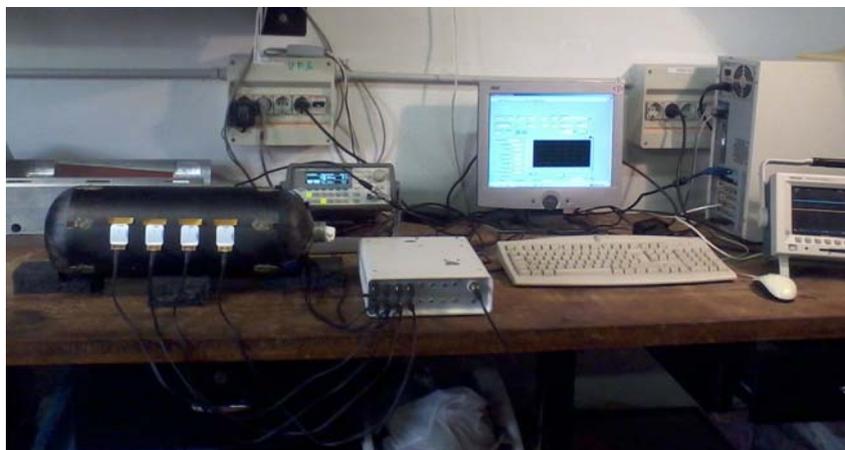
Figure 1 Programmable acquisition system for active SHM on COPV with piezopolymer interdigital transducers.

The complete SHM laboratory system is shown in Figure 1. According to a preliminary characterization of Lamb wave modes of the cylindrical part of the COPV, has been decided to use the anti-symmetric A0 mode at 220 kHz with $V_{\text{phase}} = 2200$ m/s. The plan view of the cylindrical portion investigated is shown in Figure 2 .

A complete acquisition system with programmable parameters has been carried out. The electronic box is capable of 16 transducers with operation in pitch and catch mode.
