# A Preliminary Analysis about the Application of Acoustic Emission and low Frequency Vibration Methods to the Structural Health Monitoring of Railway Axles

Stefano Bruni, Michele Carboni\*, Daniele Crivelli, Mario Guagliano, Pawel Rolek

Department of Mechanical Engineering, Politecnico di Milano, Via La Masa 1, 20156 Milano, Italy  
[michele.carboni@polimi.it](mailto:michele.carboni@polimi.it)

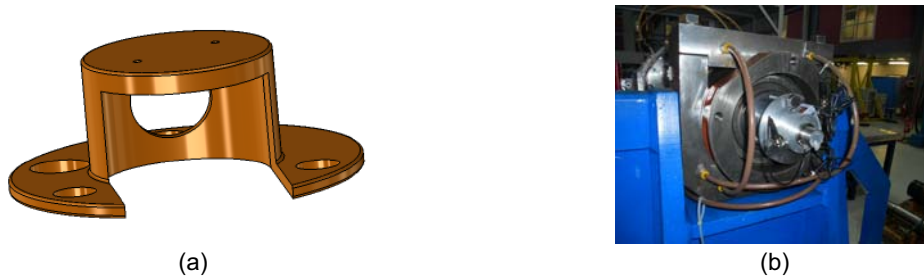
Figure 4: Custom made carter to hold the sensor and the preamplifier: a) CAD model; b) application at the axle end

AE and LFV were acquired to monitor damage development during the application of multiple repetitions of the block loading sequence. In particular, AE was applied at one free end of the axle (Figure 3) using a custom made carter (Figure 4) designed to hold in position the sensor and its pre-amplifier. The rotating group is then connected to a sliding contact to bring the signals to the AE acquisition system (Vallen AMSY-5). The custom carter allows the positioning of the sensor without removing the whole assembly, with the aid of a thin sheet metal part. The sensor is then coupled to the axle with grease, to avoid the formation of air bubbles (which will attenuate the signals). The assembly is then checked regularly to ensure that the grease has not deteriorated or moved away.

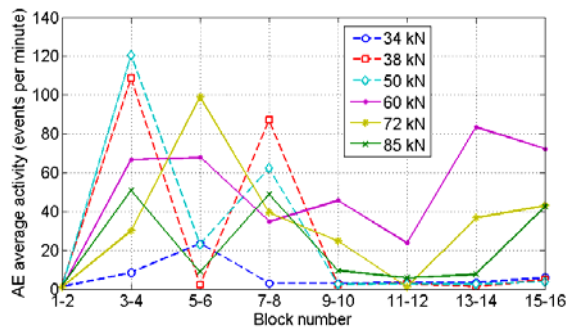
Figure 8: Acoustic Emission activity at different load levels

By separating the AE data at different load levels (Figure 8), it can be seen that after the first eight repetitions the AE data show few activity at low load levels, while the higher levels show an increasing trend. It has to be noted that since the crack propagation is of low entity so far, the present activity can be considered as a baseline for the detection of AE activity related to more consistent crack propagation.
