# On-line Condition Monitoring and Remote Fault Diagnosis for Marine Diesel Engines Using Tribological Information

Xinping Yan\*, Zhixiong Li, Chengqing Yuan, Zhiwei Guo, Zhe Tian, Chenxing Sheng

Reliability Engineering Institute, School of Energy and Power Engineering, Wuhan University of Technology, Wuhan 430063, China  
[xpyan@whut.edu.cn](mailto:xpyan@whut.edu.cn)

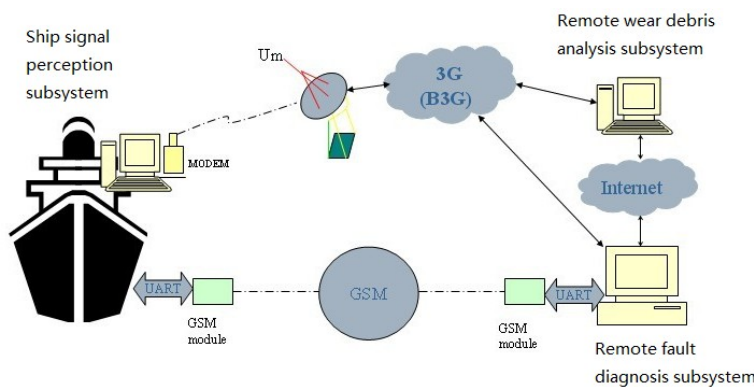
Figure 1: The sketch diagram of the proposed fault diagnosis for marine diesel engines.

This paper presents a new development of remote on-line fault diagnosis system for a series of real ships. It consists of a condition monitoring subsystem in the ship and a fault diagnosis subsystem in laboratory centre. The 3rd generation telecommunication (3G/B3G) wireless communication system has been used to connect the two subsystems. A microscopic image processing technique based on-line ferrographic monitor is adopted to analyze the wear debris characteristics of the engine oil, and an on-line moisture and viscosity detection sensor is used to monitor the lubricant condition. A feature selection method based on the Shannon mutual information is followed to rank the oil features.

The sketch diagram of the proposed fault diagnosis for marine diesel engines is shown in Figure 1. Two on-line sensors have been employed in the present diagnosis system. One is the on-line ferrographic sensor (Wu, Mao, Wang, Wu and Xie, 2009). The other is the on-line oil moisture and viscosity detection device (Yan, Sun, Yin, Li and Liu, 2011). The on-line ferrographic sensor uses the image processing technology to calculate the index of particle covered area (IPCA) and hence to count the numbers of the large wear particles (Wu, Mao, Wang, Wu and Xie, 2009), and the moisture and viscosity detection is realized by the use of the linear relationship between the oil moisture content and the color saturation.

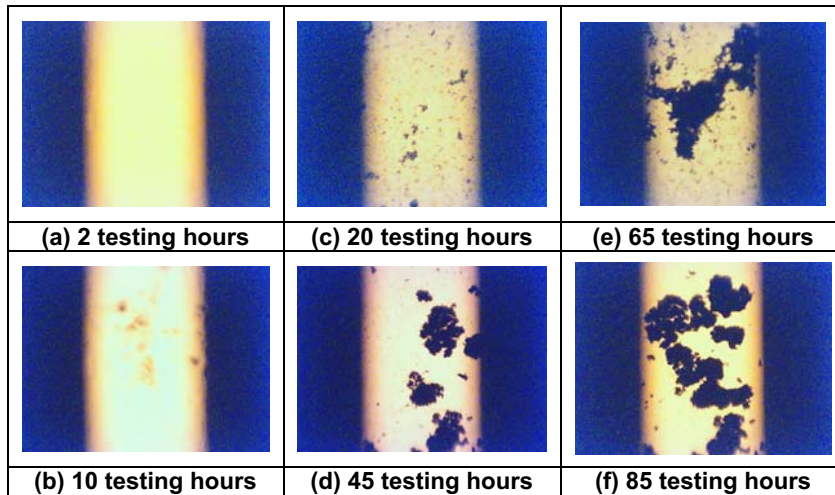
Figure 2: The ferrographic images of the diesel engine at different testing time.

Figure 2 shows the ferrographic images of the diesel engine using the on-line ferrographic sensor. The on-line IPCA monitoring results is shown in Figure 3. One can note that in Figure 2 the numbers and area of large wear particles increase gradually with the severity of the engine fault. Obvious large wear particles appear around 45 testing hours, and severe heavy-worn particles emerge during 65 to 100 testing hours. Meanwhile, it can be seen in Figure 3 that in the early stage of the testing the IPCA value maintains at a relative low lever while after 40 testing hours it increase rapidly. The average IPCA value is 367 from 50 to 100 testing hours and the maximum IPCA value reaches up to 450. These IPCA values are much larger

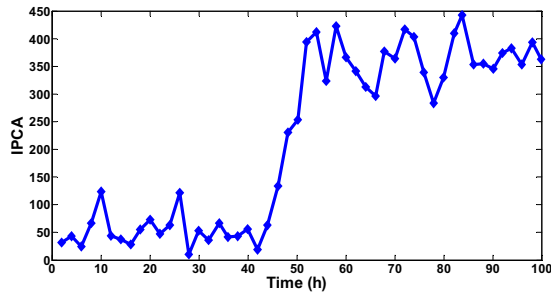
Figure 3: The curve of the index of particle covered area (IPCA).

than a normal value of 50. As a result, the abnormal operation state of the diesel engine has been detected effectively using the IPCA.

Compared with Figure 5, the IPCA curve in Figure 3 is concordant to the wear progress of the diesel engine. During the period of 40 to 50 testing hours, the IPCA curve changes greatly from normal to abnormal whilst the wear type and size in Figure 5 have similar changes. It is evident that with the development of the gear crack the number of the chunky and fatigue particles increases correspondingly. From the above analyses, it can be concluded that the metal-to-metal contact caused by the engine fault has generated informative wear particles. By the use of interaction information based feature selection, the most suitable indicator (the IPCA) has been selected to be incorporated into the remote on-line fault diagnosis for marine diesel engines. Satisfactory fault detection performance has been achieved.

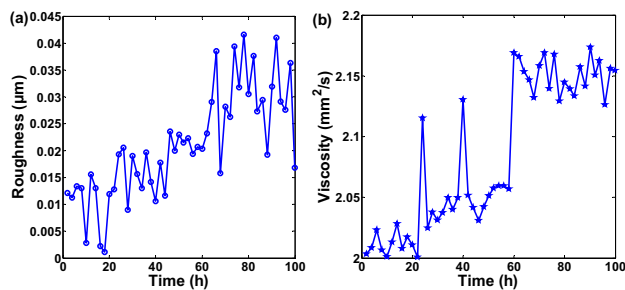
Figure 4: The curves of the other features: (a) roughness, and (b) viscosity.

To compare the IPCA with other features, the variations of the surface roughness of large wear particles and the oil viscosity are given in Figure 4. It can be seen in Figure 4(a) that the order of magnitude of the

roughness is too small and the roughness values in abnormal engine operation condition are close to the values in normal condition. Although the roughness in severe faulty condition is larger than that in the slight wear condition, it is still difficult to assess the engine health condition according to the roughness values via the on-line manner. In Figure 4(b), the viscosity curve is similar to the IPCA curve. It can be used to detect the engine fault on-line. However, some singular points may influence the viscosity value significantly, such as the points at 22 and 24 testing hours. This is because the viscosity reflects the wear particle changes to certain degree but other factors may also influence the viscosity variation, such as the oil temperature, etc. In contrast, the IPCA has no such problems and hence is superior to the viscosity in the on-line fault detection. This point of view is also proven by the feature selection results in table 2.

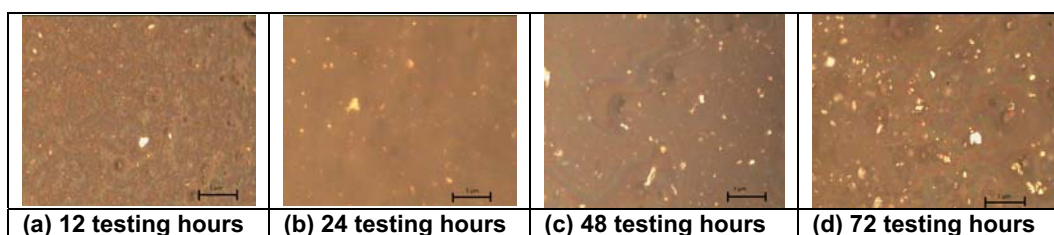
Figure 5: The filtergrams of the lubrication oil samples

In Figure 5(a), when the engine was in early stage of the test, a small amount of wear debris was generated. The wear of the engine was normal because only a few rubbing particles ( $<0.1 \mu\text{m}$  in size) were observed. The size and amount of rubbing particles increased slightly in Figure 5(b) after another 12 testing hours. This means the engine working condition has become terrible. Nevertheless, the wear particle type suggested that the wear of the engine was basically normal. However, the health condition of the engine changed in Figure 5(c~d). Large laminar particles (approximately  $3 \mu\text{m}$  in length) appeared. The severity of the crack failure grew enough to destroy the lubrication boundary of the gear pump, leading to direct contact between the gears. One can be noticed in Figure 5(d) that a large amount of chunky and fatigue particles were generated. These particles are good indicators of lubrication breakdown.
