Inwards Doors Blocked by Fire Induced Overpressure in Airtight Apartment: a Real Case in Germany

Sylvain Brohez*, Pierrick Duhamel

University of Mons, Faculty of Engineering, Department of Chemical Engineering, 20 Place du Parc, 7000 Mons, Belgium.
sylvain.brohez@umons.ac.be

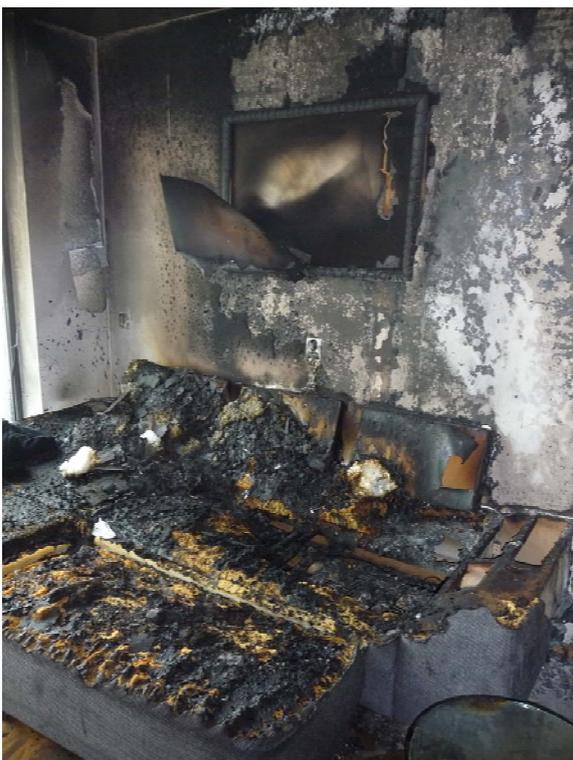
In the night of the 5 February 2013, a fire started in the living room of the apartment. The occupant was asleep, woke up because of the fire noise and ran into the living room where he saw flames at the end of the room, the sofa was in fire (Figure 1). His first idea was to put out the fire by using water. He went to the kitchen and began to fill up a bucket with water but it took too much time. The fire extended very fast and the heat became huge. He decided to get out of the apartment. Although the front door was not locked, he could not open it; the door was like locked (Figure 2). He tried to open it several times, but he had no chance. After several unsuccessful attempts, he ran back in the bedroom to escape through the balcony door (Figure 3). The same effect was observed. He could not open the window door; this door was also like locked. Then, he closed the bedroom door because of incredible smoke coming from the living room (Figure 4) and put some clothes at the bottom of the door to protect himself from fumes. He tried to open the balcony door again. After several times, the occupant was able to open the door. He escaped with injuries but he survived.

Figure 1 : the sofa

The subsequent investigation revealed that a defective electrical appliance was at the origin of the fire, which spread to the sofa. The damage to the apartment was limited to the living room and more specifically to the sofa and the pictures located in the upper part of the walls. There was no structural damage. The first glass of the window in the living room close to the sofa bursted because of the fire (Figure 5), but the two others glasses of the triple pane glazing were not deteriorated. The occupant confirmed that all doors and windows were closed before the accident.

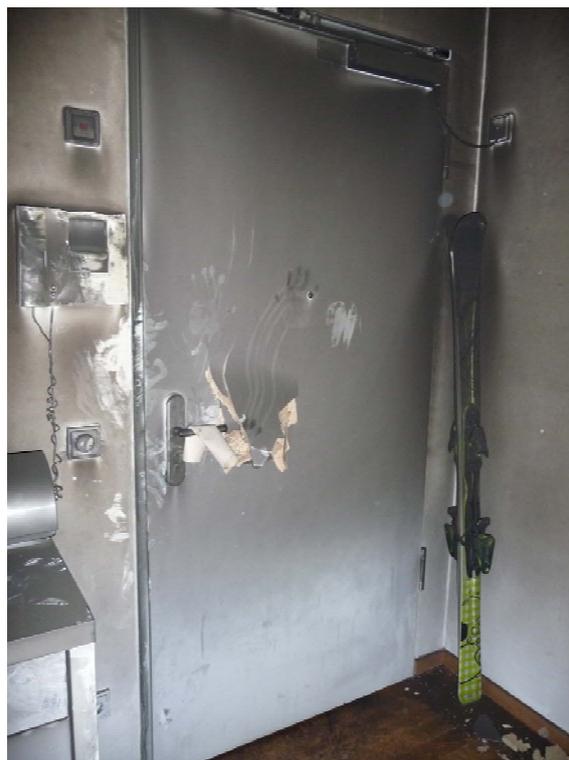
Figure 2 : The front door

In the beginning of the journalist investigations, no one could give any satisfactory answer. The fire department in Cologne told him first, that maybe the material of the doors expanded because of the heat and that could be the reason that the occupant was not able to open the doors (the front door and also the balcony door).

A couple of days after the fire accident, the journalist tested both the front door and the balcony door from the bedroom: they were undamaged and worked perfectly. He shoot some photos of the doors and sent them to the fire department in Cologne. They were helpless and had no more idea. Thanks to the advice of the fire department, the journalist called Dieter Brein, the leader of the German institute KIT (Forschungsinstitut für Brandschutztechnik, in Karlsruhe) which is a department of the University of Karlsruhe and told about this fire case. He was totally surprised because he had never heard before about a case like this. The leader of the institut KIT did some investigations and found a study published some months ago about the fire hazard in passive house (Brohez, 2012). This study was about CFAST zone modelling for investigating how much the characteristics of a passive house such as airtightness, ventilation network and thermal insulation could affect the fire development.

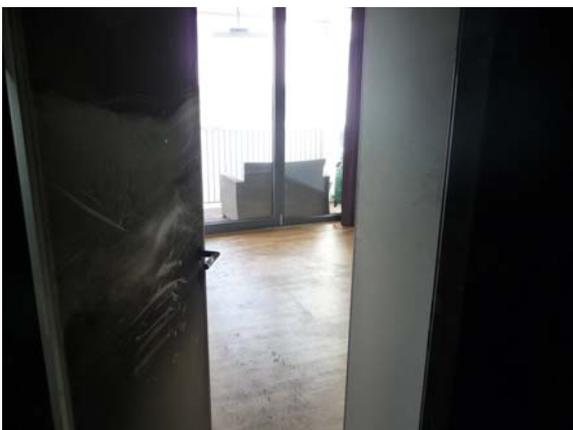
Figure 3 : The bedroom with the balcony

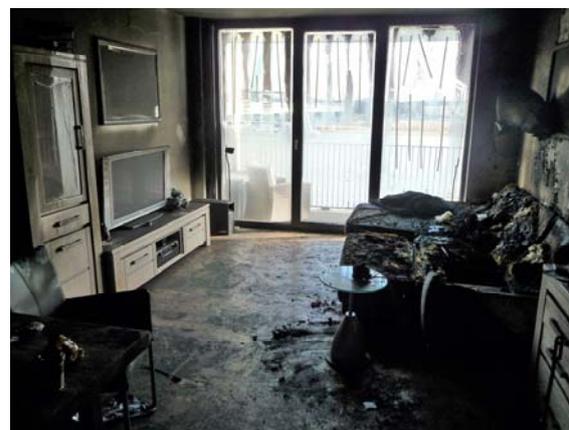
Figure 4 : The living room

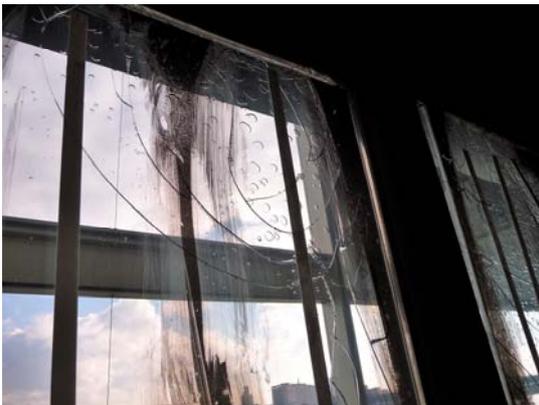
Figure 5: First glass of the triple-pan window

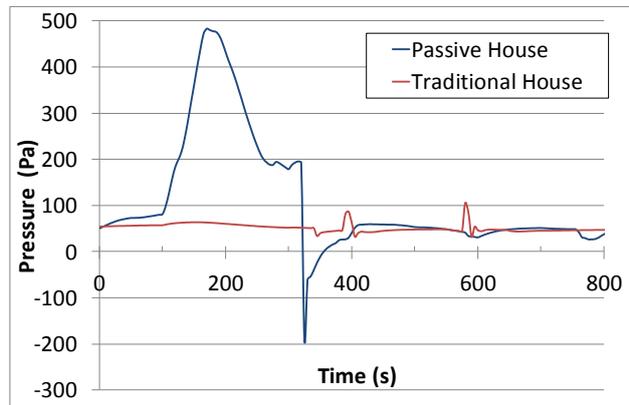
Figure 6: Fire-induced overpressure, (Brohez, 2012)

The fire-induced overpressure is linked to the HRR. When the HRR increases, the pressure rises as well. Then due to a lack of oxygen, the HRR decreases in the fire room and the pressure decreases consequently. From the CFAST simulations, a significant difference in pressure rise (500 Pa) due to the thermal expansion

of fumes was calculated due to the airtightness of the passive house in comparison to the one calculated in a traditional house (10 Pa). Moreover, it can be noticed that the duration during which the fire-induced overpressure is higher than 150 Pa could be as long as 3 minutes; 150 Pa being the threshold below which most people could open an inward door (Voorbij, 2001, Vanhaverbeke, 2015). However, without any fire test validation at large scale during this project, questions raised from the scientific monitoring committee about the integrity of airtightness in case of fire and thus about the ability of passive house to maintain such a level of overpressure induced by the fire.
