Packed Bed Performance Analytics Based on Gamma Scans

Scott Vidrine^{a*}, Giuseppe Cipolla^b, Lowell T. Pless^c

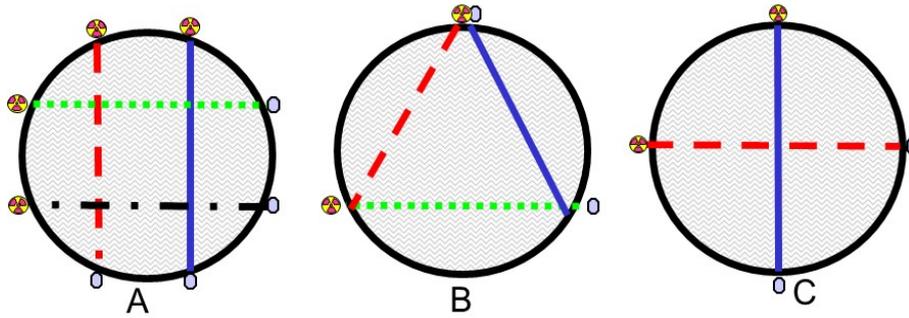
Figure 1. Typical Gamma Scanline Orientations: A for diameters 1.5 m and larger, B for diameters 0.5 – 1.5 m; C for diameters less than 0.5 m.

Figure 1 shows the most typical orientations for conducting a gamma scan on a packed tower. These scans are conventionally called grid-scans.

The purpose for doing multiple scans of a packed tower as shown in Figure 1 is to determine the state of the liquid distribution. The foundation for this analysis is the Beer-Lambert law as expressed here:

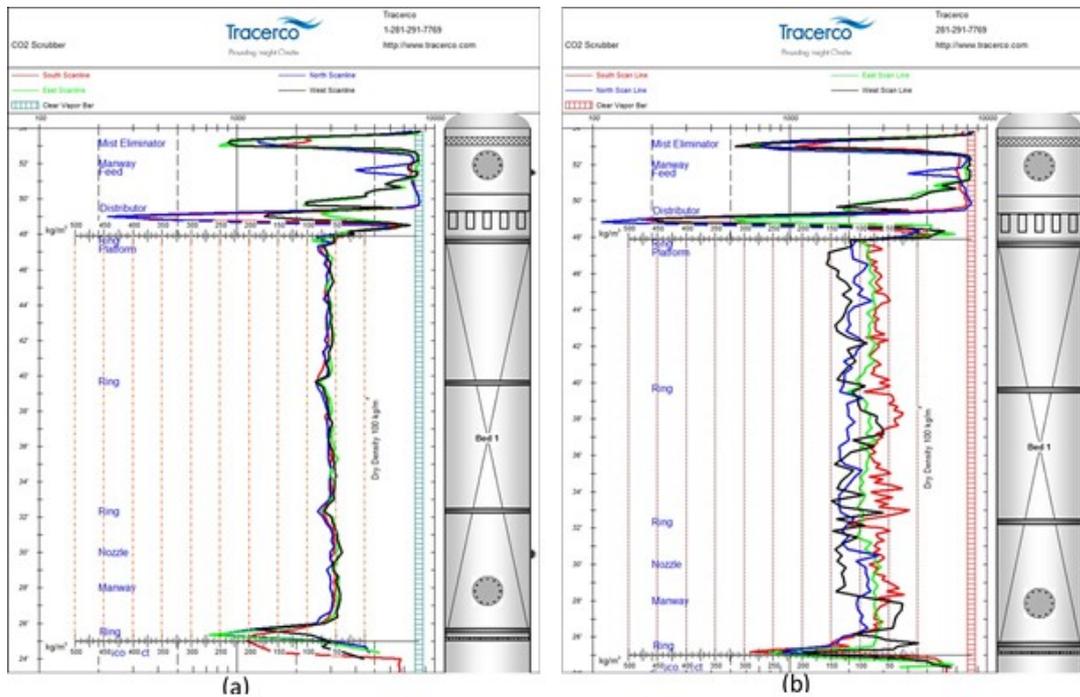
Figure 2 (a) Gamma scan results showing good liquid distribution due to the uniform response. (b) Gamma scan results showing liquid maldistribution since there was no uniform response among the scanlines.

On the basis that χ was indeed kept equal, then the multiple sets of scan data from a packed column grid scan could be simply visually compared to each other. The reasoning since all scan parameters were constant, particularly the length or path of radiation through the column (χ), uniform liquid distribution would be confirmed by all four scans detecting identical radiation. Figure 2a is a typical example of a grid scan showing all four scanlines matching, implying good liquid distribution.

However, when there was some variance in the radiation measurement and the sets of scan data do not seem to match very well then the liquid maldistribution would be blamed. Comparing the sets of scan data, lower radiation counts (higher density) indicated more liquid and higher counts (less density) indicated less liquid, therefore liquid maldistribution. An example of this type of conclusion is demonstrated in Figure 2b.

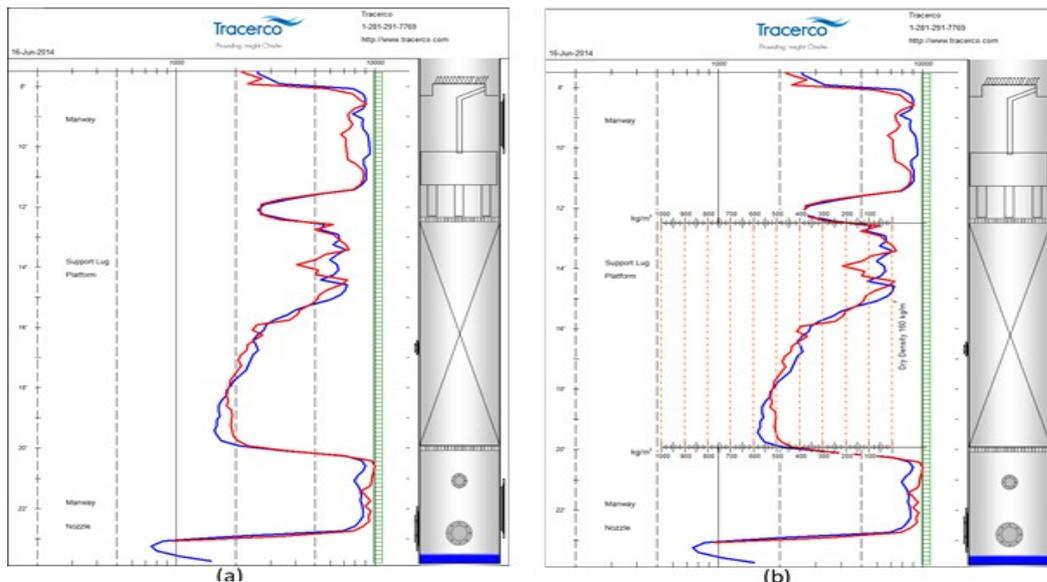
Figure 3. (a) Initial gamma scan results from small diameter column. (b) Gamma scan results, enhanced with liquid retention scale, showing missing packing at top of bed.

Figure 3a shows the gamma scan results from a small-diameter packed tower (only two scanlines performed due to the small diameter). The tower diagram on the right side of Figure 3a shows where the bed of packing is supposed to be per the reference tower drawing. There is a reduction in radiation counts from the Clear Vapor region at the expected elevation for the top of the bed. After a short distance into the bed the radiation counts decrease. The question is, what is the operating condition of the bed? Are the lower counts (higher density) liquid holdup (flooding) at the bottom of the bed? Or is the radiation counts at the bottom of the bed “normal” and something has happened to the packing in the top of the bed? A visual or qualitative evaluation of the radiation counts cannot answer these questions with confidence.

Figure 3b shows the gamma scan results from Figure 3a with the liquid retention scale added. Note that the density of the dry packing is 160 kg/m^3 and the top of the bed has a density essentially equal to this. However, the tower was operating and there was liquid traveling down through the packing. Where is the additional density from the retained liquid? The overall density at the top of the packing should be the combination of retained liquid and packing densities. Since the scan results show the overall density to be nearly equal to the dry packing, either there was no liquid (obviously not the case) or packing was missing. This was a bed of random packing. The PackView™ analysis made it conclusive that portions of the packing were missing. The high density in the bottom of the bed was likely crushed packing retaining an excess of liquid. Eventually entry into the tower confirmed these results.

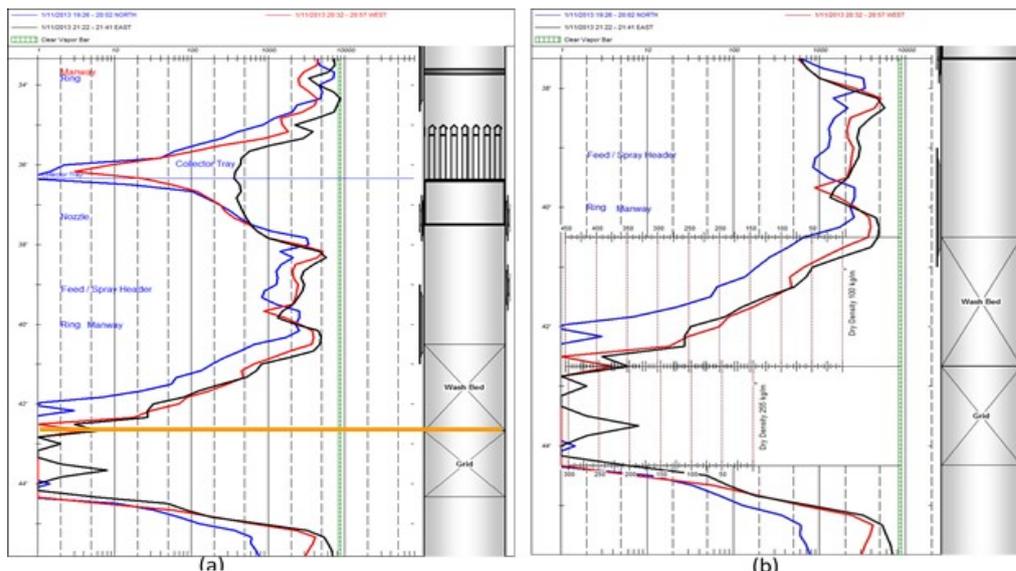
Figure 4. (a) Initial gamma scan results of crude vacuum column showing bed placements and high density (very low radiation intensity) through the wash bed grid. (b) Gamma scan results, enhanced with liquid retention scale, showing wash bed grid either completely coked or flooding with retained liquid. Excess liquid backing up into wash bed packing.

Figure 4a shows the gamma scan results from a crude vacuum tower (the fourth scanline was not performed due to limited access). One of the biggest problems with crude vacuum tower operation is managing the coking (fouling) of the wash bed. In this example plant operations suspected the wash bed had coked up so the gamma scan was done to assess the situation. As shown on the tower diagram on the right side of Figure 4a this wash bed consisted of two different types of packing. The top section was typical structured packing while the bottom section was grid packing. The scan results showed the bottom section to be very dense, as the radiation intensity was less than 5 counts, essentially background (no radiation passing through the tower). Based on this result the diagnosis was that the grid section was coked and/or flooding with liquid, but plant management was not convinced. Grid packing is dense packing so what if the radiation source was too small? In other words, some radiation would pass through the packing from using a larger radiation source and then perhaps the tower would not appear to be flooding.

Figure 4b shows the gamma scan results from Figure 4a with the liquid retention scale added. The dry density of the grid packing is 255 kg/m^3 . The density of the process material inside the grid packing, based on the scan results, was calculated to be approximately 300 kg/m^3 . Grid packing is very open packing and the typical liquid retention density for grid packing in this service is $80 - 100 \text{ kg/m}^3$. The density calculated from the scan data is far above this so the grid was coked and/or flooding. Therefore, the scan radiation source used on this tower was more than adequate. The advanced analysis proved that if this wash bed had not been fouled with coke and flooding there should have been $30 - 50$ radiation counts passing through the tower, rather than less than 5.

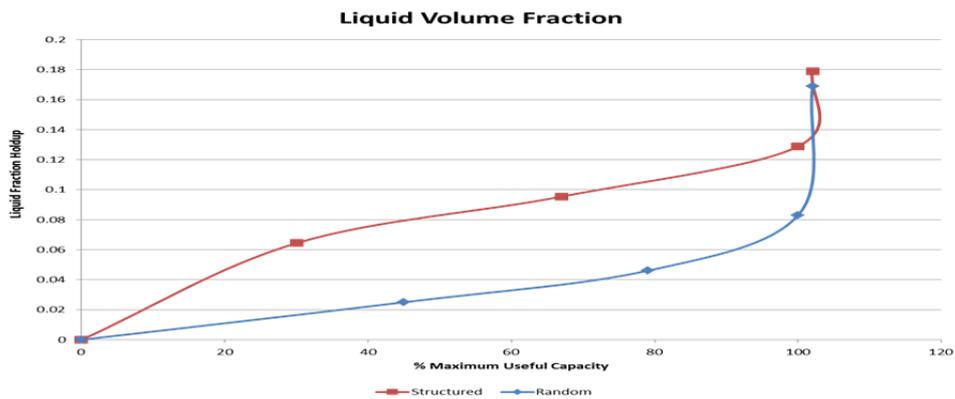
Figure 5. Typical curves showing maximum capacity for general types of packing as a function of liquid holdup.

An additional computation confirmed this diagnosis. The liquid volume fraction was calculated by dividing the liquid retention density of 300 kg/m^3 by the process liquid density (800 kg/m^3). The resulting liquid volume fraction was 0.38. Figure 5 shows typical capacity curves from studies of packing capacities. Note that usually packings reach flood stage with liquid volume fractions greater than 0.12. Therefore, the grid packing far exceeded its maximum useful capacity.

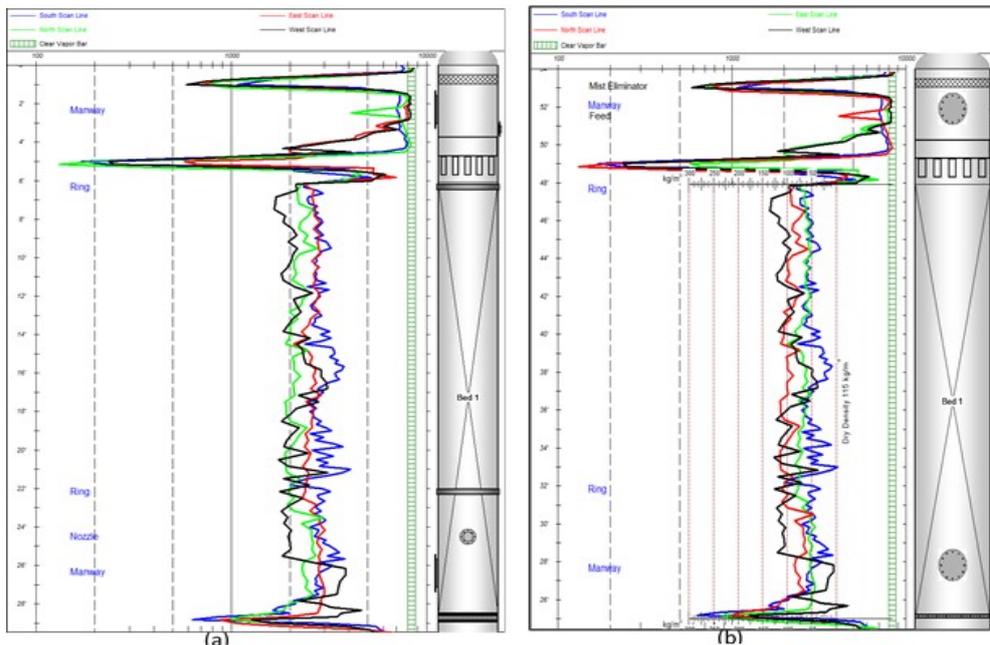
Figure 6. (a) Initial gamma scan results showing what appears to be liquid maldistribution as no uniformity of the scanlines through the bed. (b) Gamma scan results, enhanced with liquid retention scale, showing large density differences among the scanlines. One side of tower (blue scanline) shows almost dry packing as liquid retention density is almost the same as the dry packing density.

Figure 6a shows the gamma scan results of a packed bed in a CO₂ scrubber where the resulting product gas was out of specification on CO₂. The gamma scan showed no major problems with the scrubber internals other than the possibility of liquid maldistribution. The typical qualitative evaluation seems to show there is a problem in the bed of packing. The four scanlines do not match each other very well indicating that the overall density between the four sets of data are different from each other. The radiation intensity counts vary from 1800 – 3600 as read from the horizontal scale of Figure 6a. But what is the severity of the liquid maldistribution? The radiation intensity or counts gives no perspective or evaluation of the actual liquid distribution quality.

Figure 6b shows the same gamma scan results from figure 6a with the liquid retention density scale added. The dry packing density is 115 kg/m³. The PackView™ analysis shows the liquid retention ranged from 10 – 130 kg/m³. In terms of liquid density across a bed of packing this was a large density difference. Reinforcing the liquid maldistribution diagnosis was the fact that one scanline (the blue data curve in Figure 6b) had almost the same overall density as dry packing alone. Thus, this scanline was nearly dry or very little

liquid on that side of the scrubber. Furthermore, the liquid volume fraction calculated, based on a process liquid density of 800 kg/m^3 , ranged from 0.01 (very low liquid fraction) to 0.16 (bordering on flooding). Therefore, the advanced analysis conclusively proved that the bed of packing was suffering from very poor liquid distribution.

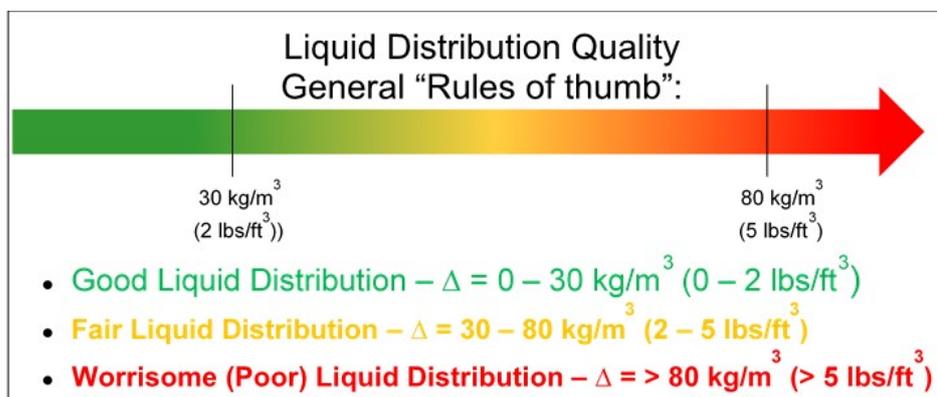
Figure 7. General guidelines for evaluating liquid distribution quality based on gamma scan results using the advanced analytics of the liquid retention scale.

Figure 7 shows general guidelines for the magnitude of liquid retention density differences seen across packed beds from gamma scans and the relative quality of liquid distribution. Please note that these are only general guidelines and may differ based on the specific service the tower performs and the overall liquid operating rate.
